Briefing on E2 Anchor Bolts – April 24, 2013

THE SAN FRANCISCO-OAKLAND
BAY BRIDGE
SEISMIC SAFETY PROJECT

1. What caused the E2 anchor bolts manufactured in 2008 to fail?

Failure of 2008 Bolts Due to Hydrogen Embrittlement

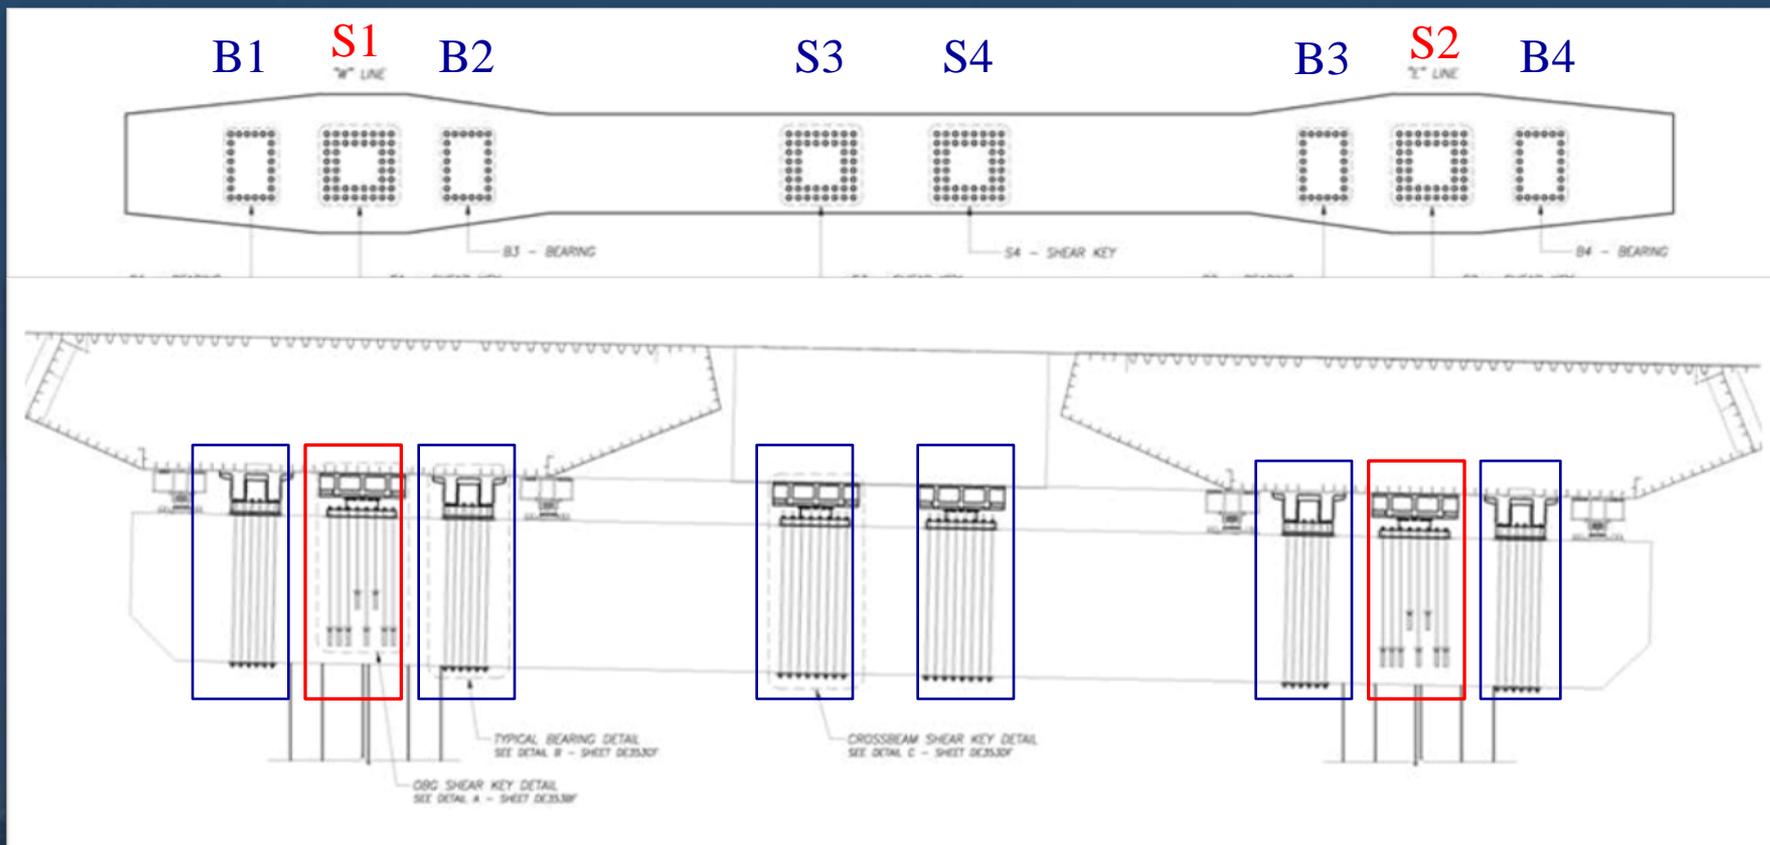
- Bearings and shear keys are secured to E2 by 3 inch diameter anchor bolts, ranging from 9 feet to 24 feet in length.
- 96 bolts manufactured in 2008 shown in red are embedded in the pier.
- 192 bolts manufactured in 2010 shown in blue are not embedded in pier.

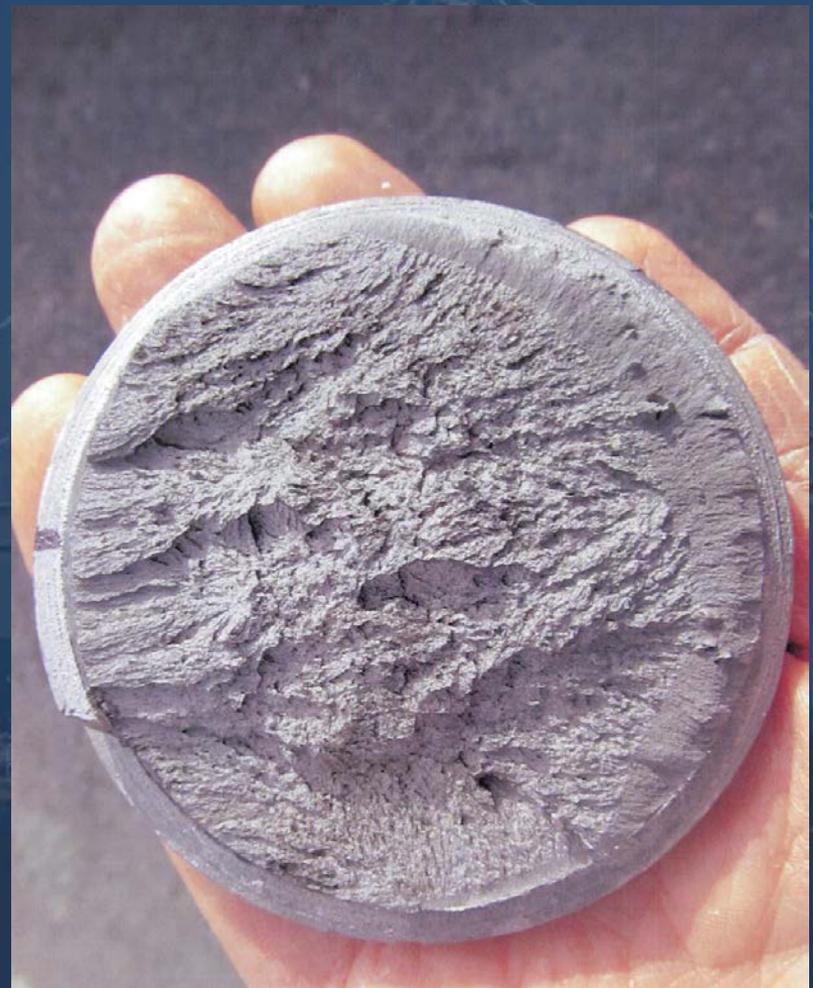
- Under detailed investigation, 2008 bolt failures are due to hydrogen embrittlement.
- Excess hydrogen in the 2008 bolts caused the threaded areas of bolts to become brittle and fracture under high tension.

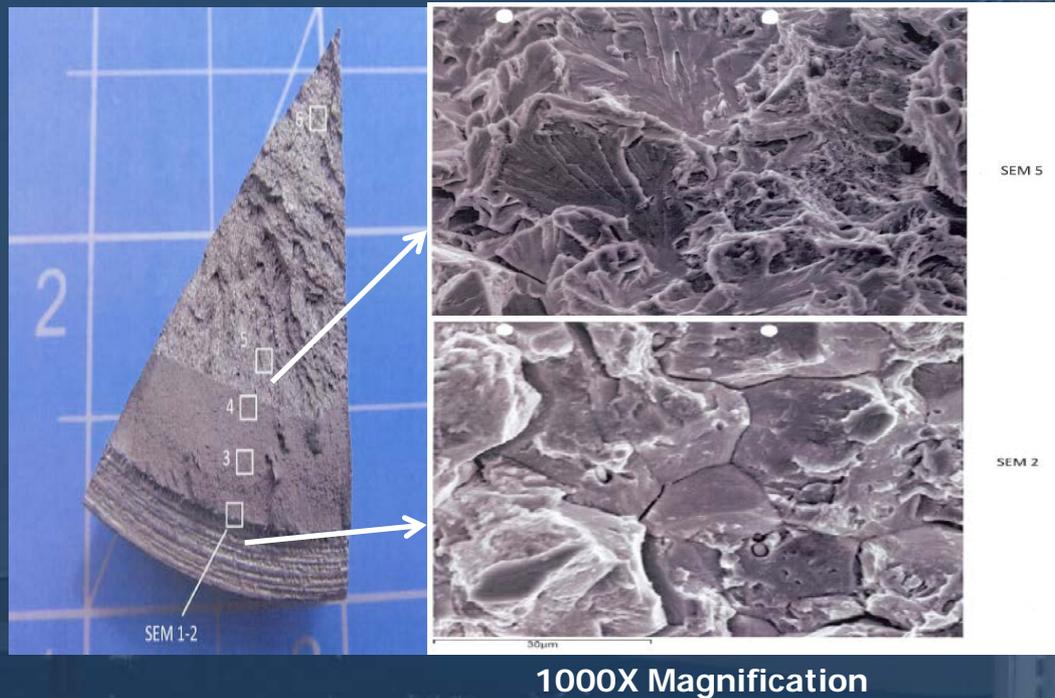
Hydrogen Embrittlement

- On-going metallurgical analysis indicates 2008 bolts were susceptible to hydrogen embrittlement due to “a lack of uniformity in the microstructure of the steel”
- Identified under electron microscope.

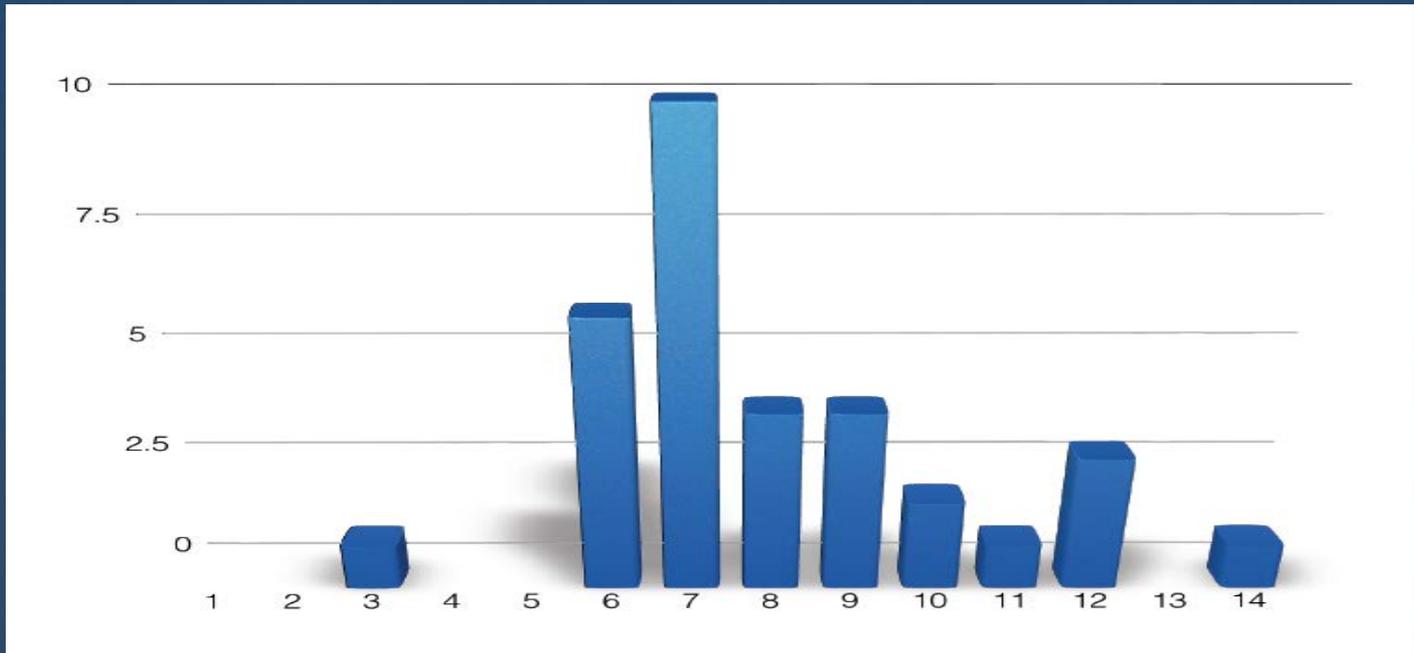
DAYS AFTER STRESSING (2008 BOLTS)

- Failure by hydrogen embrittlement is time dependent and should happen within weeks of tensioning.
- 2008 bolts failed days after tensioning. After 14 days, all 2008 bolts were de-tensioned.
- Industry standard testing protocols for A354 bolts are not time-dependent. Lesson learned: Additional material specifications and testing protocols could have reduced risk of hydrogen embrittlement.

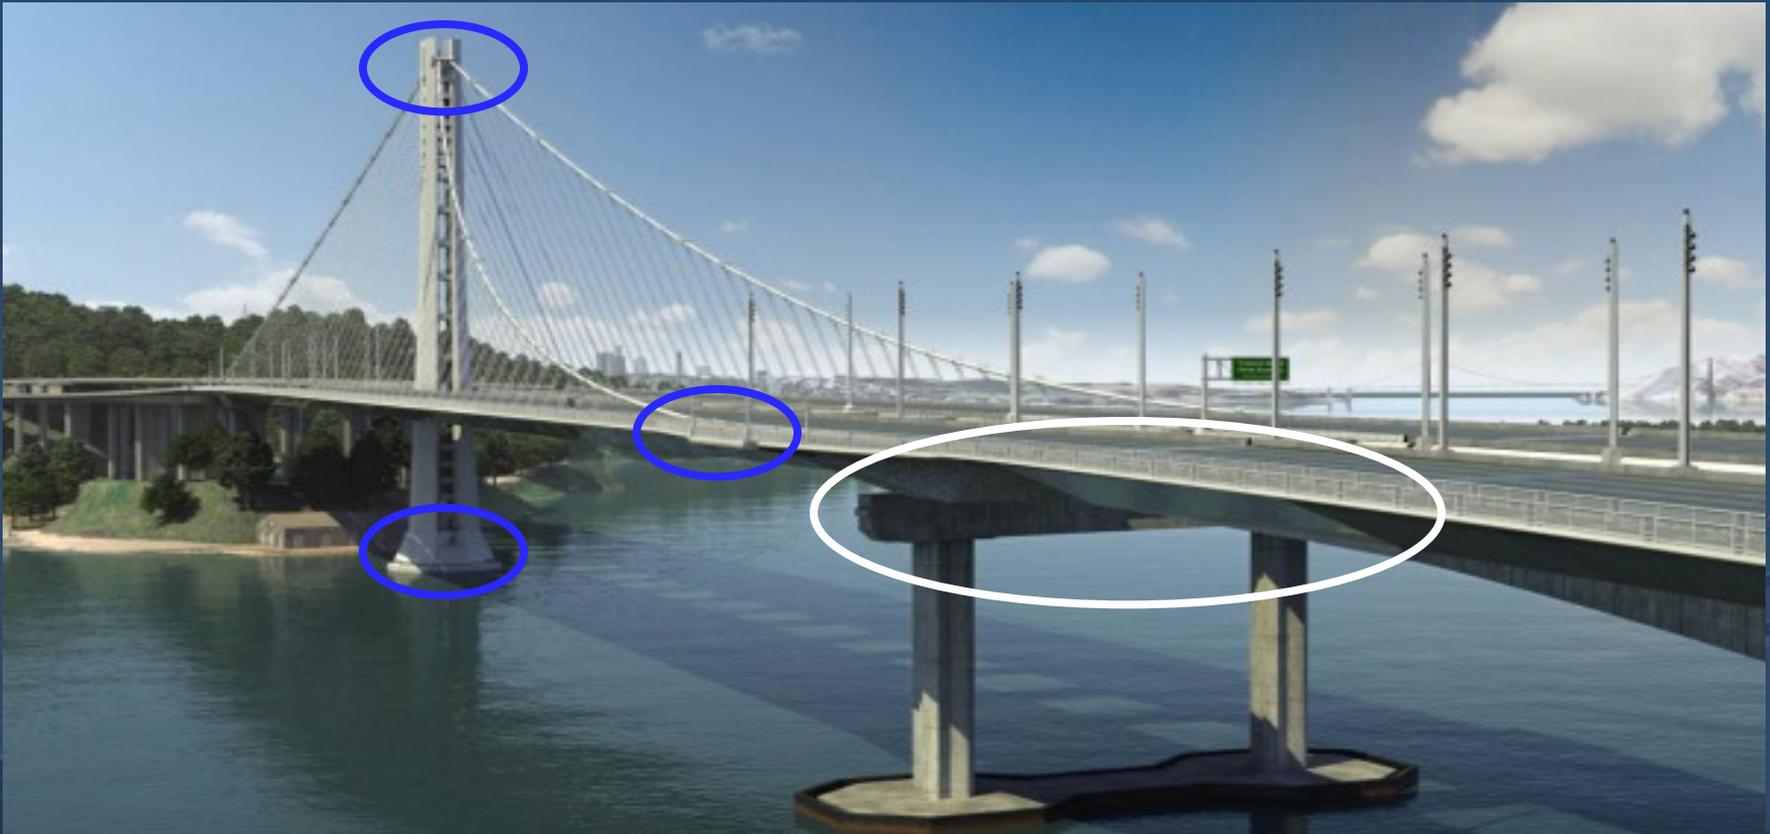
- Visual inspections of similar anchor bolts revealed no abnormalities.
- Some E2 Bearing assembly bolts are not accessible to inspection.
- Most anchor bolts at other locations are under lower tension levels.
- Prioritized Desk Audit of QC/QA results underway.
