Briefing on E2 Anchor Bolts – May 8, 2013

THE SAN FRANCISCO-OAKLAND
BAY BRIDGE
SEISMIC SAFETY PROJECT

1. What caused the E2 anchor bolts manufactured in 2008 to fail?

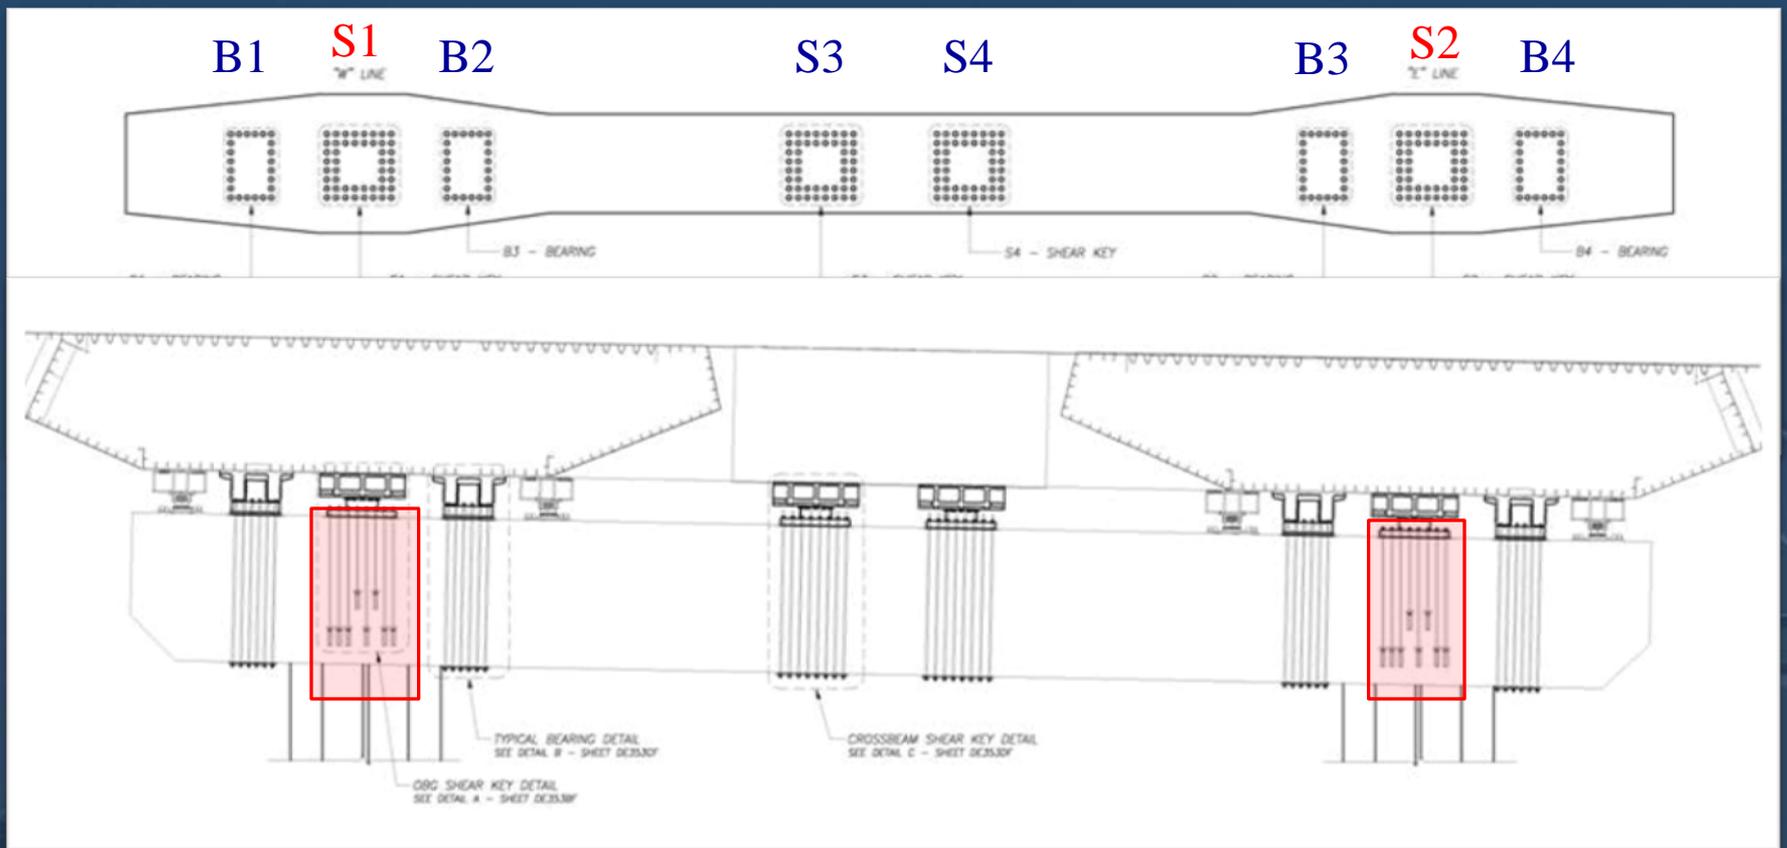
- Bearings and shear keys are secured to E2 by 3 inch diameter bolts, ranging from 9 feet to 24 feet in length and to the OBG by 2 to 3 inch diameter bolts ranging 2 to 5 feet in length.
- 96 bolts manufactured in 2008 shown in red are embedded in the pier.

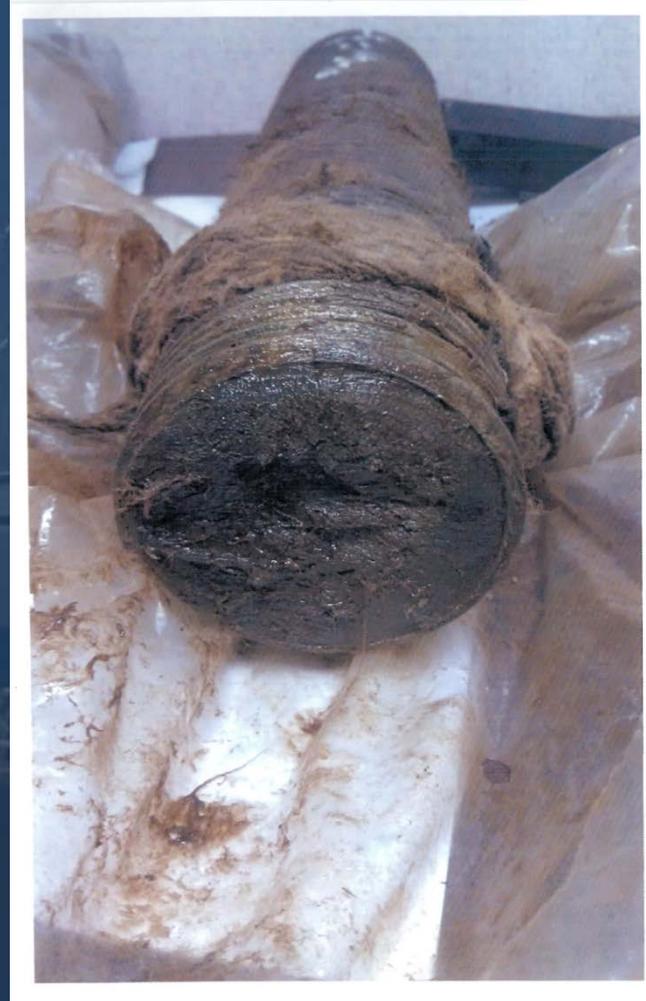
- As determined by Caltrans and the Contractor, the anchor bolts failed as a result of hydrogen embrittlement.

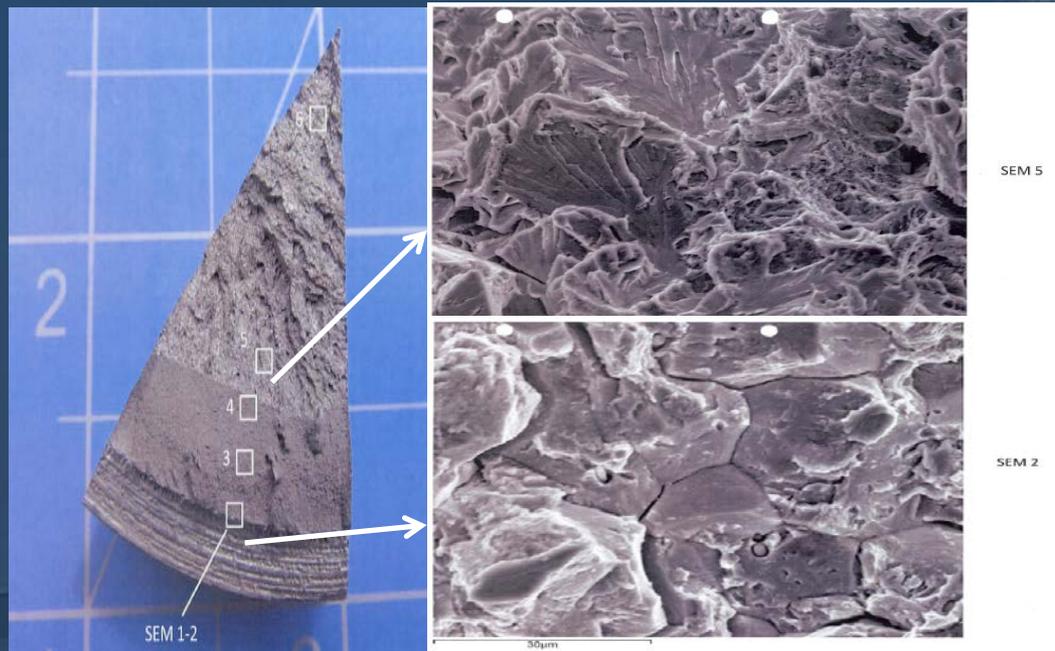
1000X Magnification

- Metallurgical analysis shows a lack of uniformity in the microstructure of the steel, with large differences in hardness from center to edge and high local hardness near surface. Further, the material exhibited low toughness and marginal ductility.

- Procurement of future A354 grade BD anchor rods should include a number of supplemental requirements to assure against hydrogen embrittlement failure.

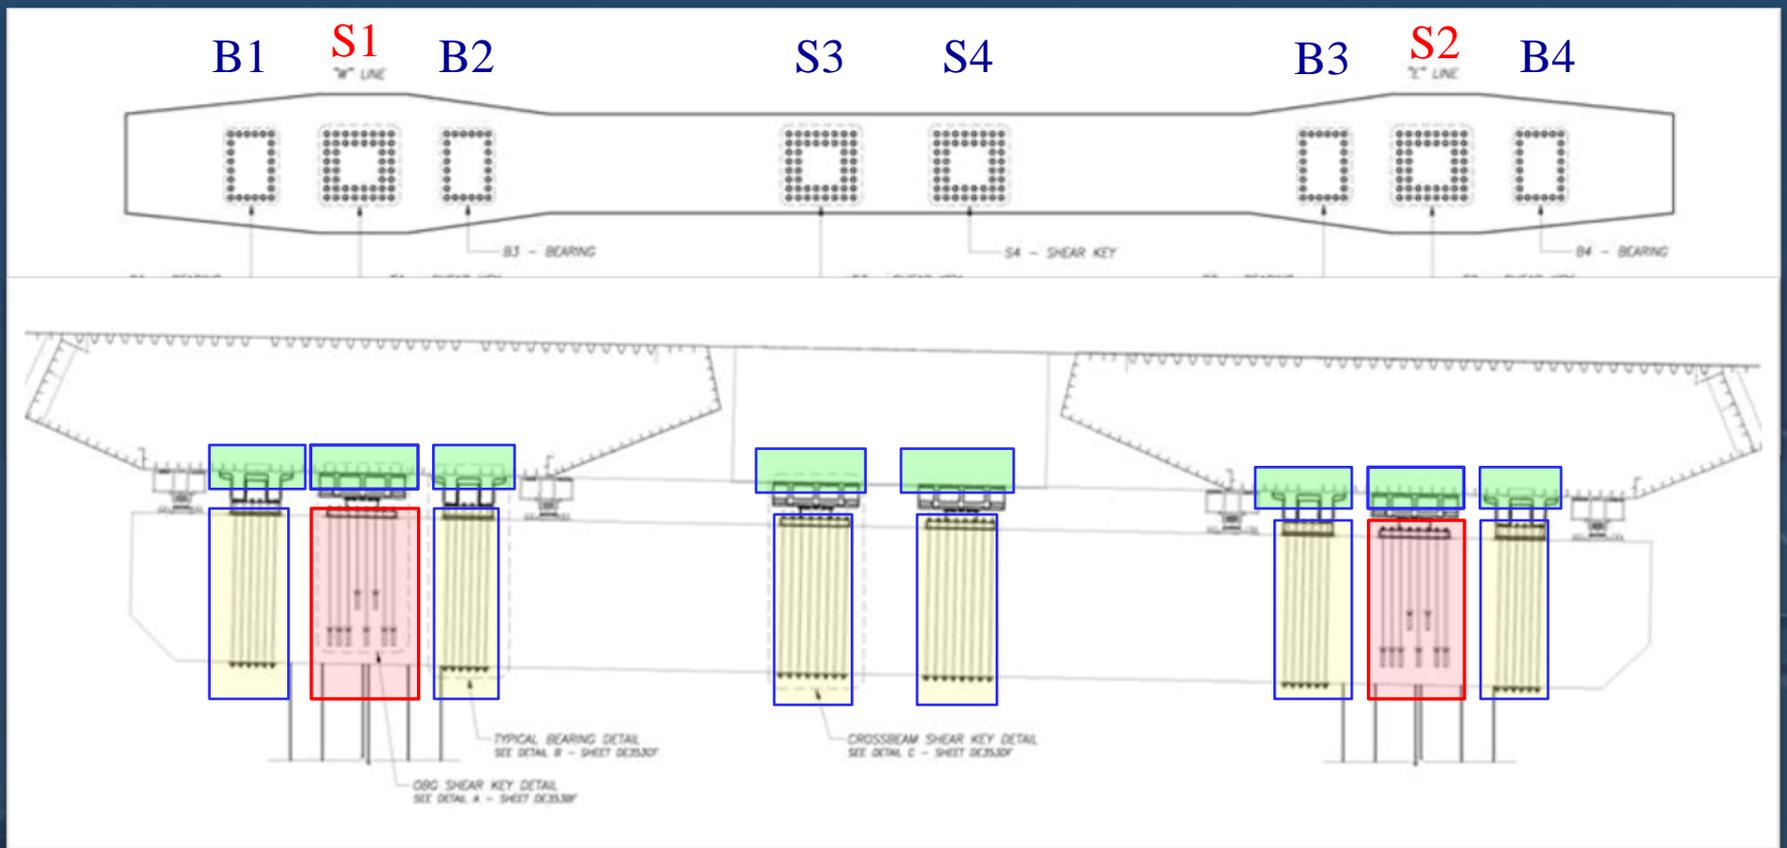
- 96 bolts manufactured in 2008 shown in red are embedded in the pier.
- 192 bolts manufactured in 2010 shown in yellow are not embedded in pier.
- 544 bolts manufactured in 2010 shown in green are connected to the OBG.
- There are an additional 432 bolts of 1 inch diameter, varying from 2 inches to 2 feet in length, that are internal to the E2 bearing assembly.

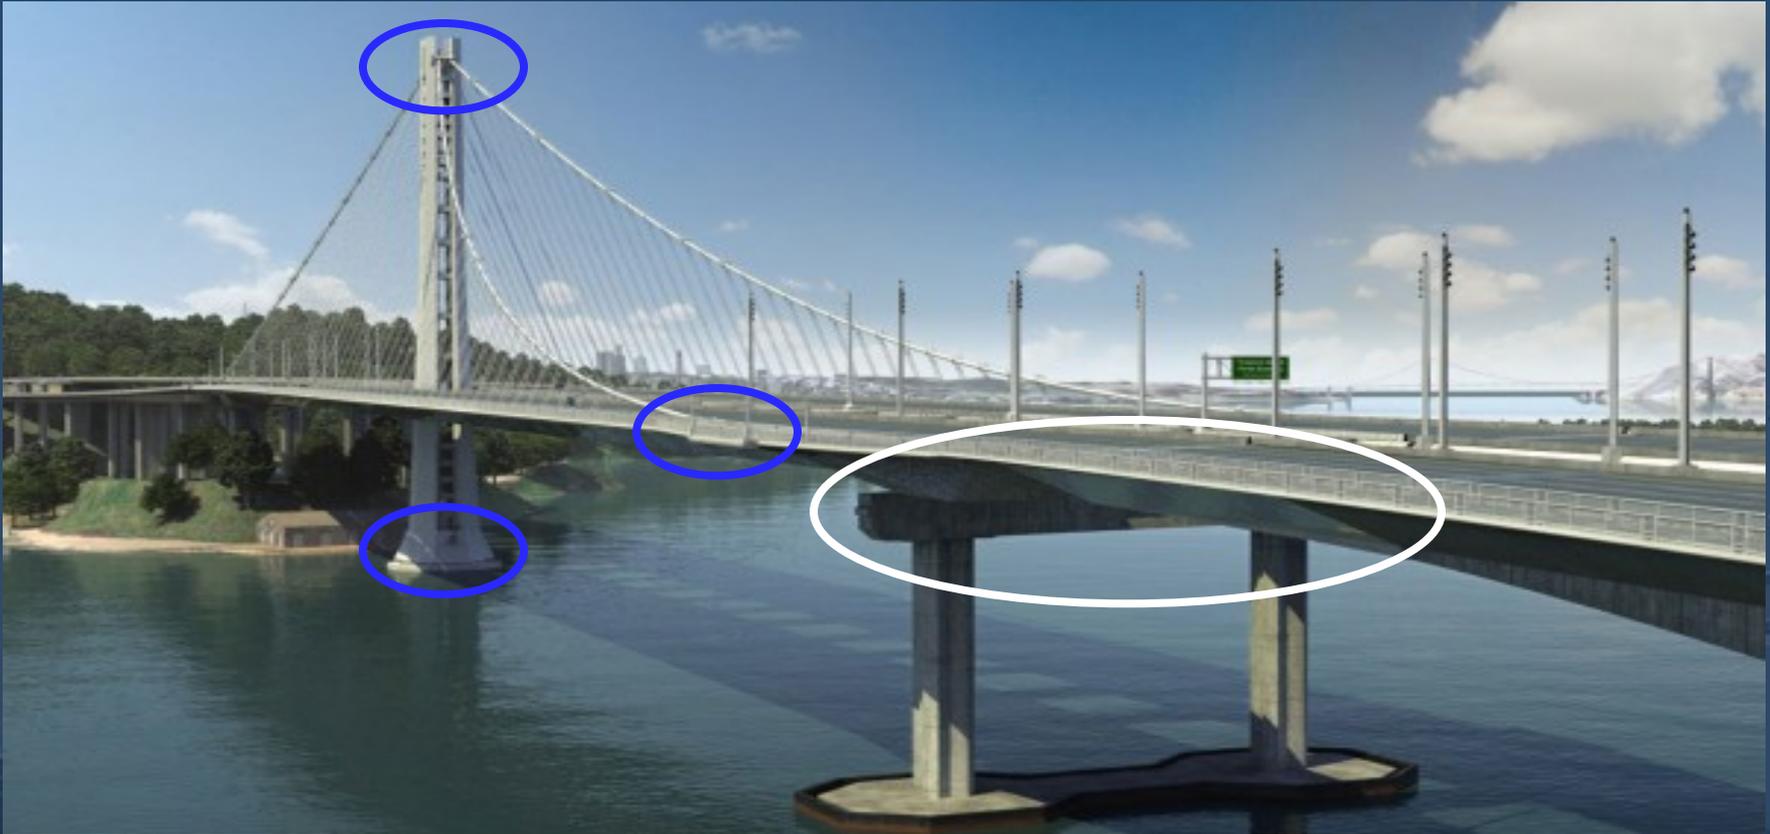
- Visual inspections of similar bolts revealed they are performing as required.
- Some E2 Bearing assembly bolts are not accessible to inspection.
- Most bolts at other locations are under lower tension levels.
