T1 Tower Anchor Rods

T1 Anchor Rod Investigation

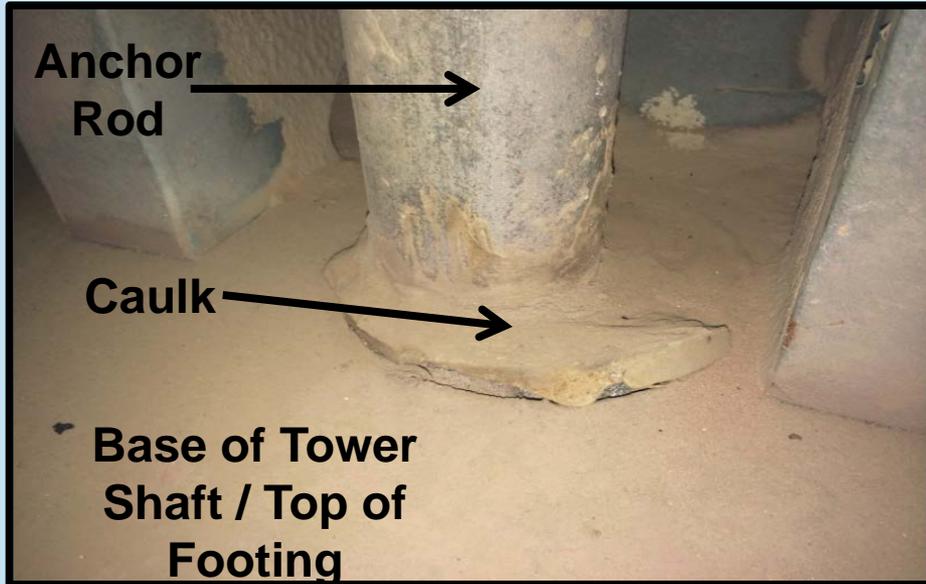
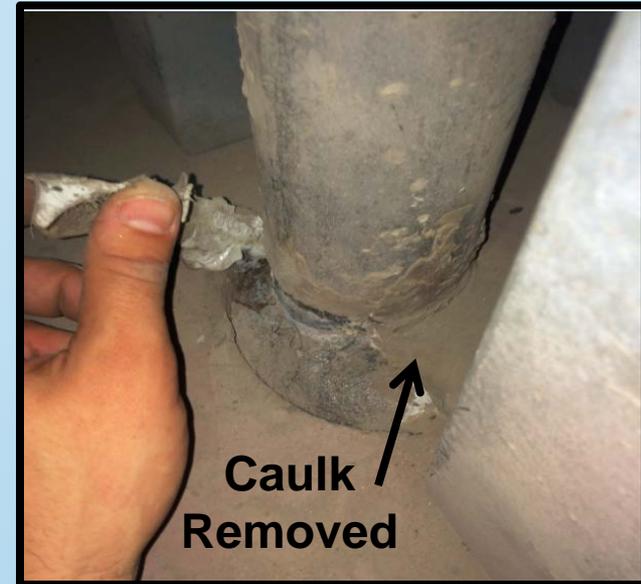
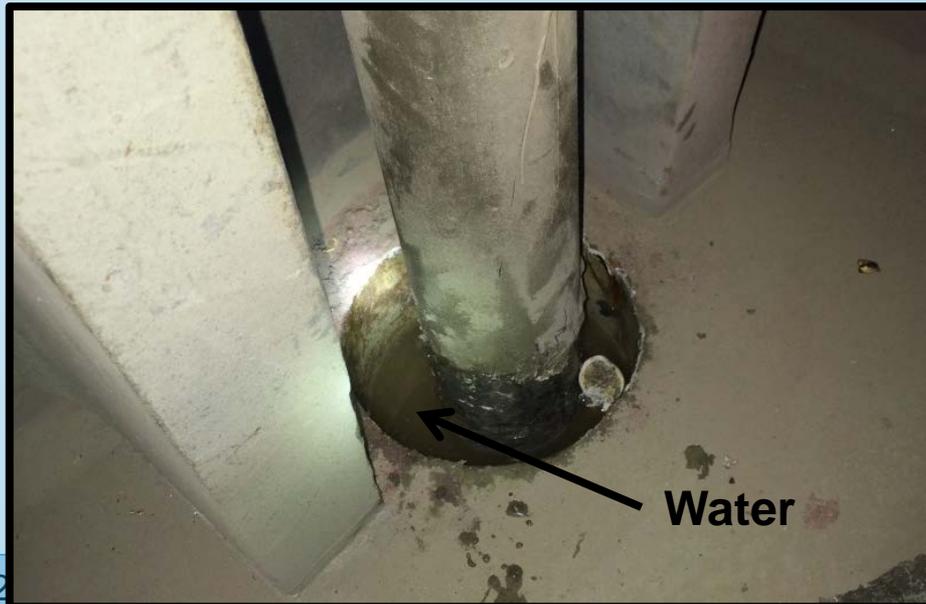
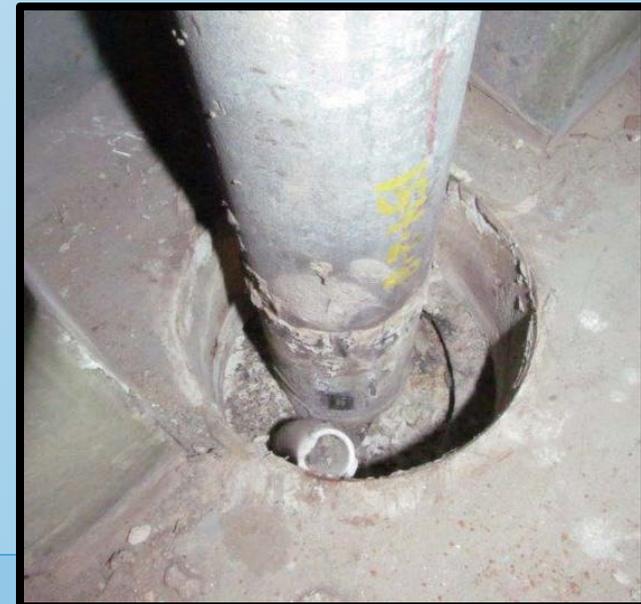
- Caulking remove around all rods.
- Moisture discovered in 95% of locations.
- Rods were greased and wrapped as per plan.
- Some rods were not fully grouted.
- Reports of some flooding due to rain during construction.
- Dehumidification is on.
- On going investigations
 - Boroscope of holes
 - Testing of water
- Water has not reappeared in dewatered holes.
- Lower tension levels in these rods rules out stress corrosion cracking in future.
