Project# 04-0120F4

Metallurgical Analysis of Bay Bridge Broken Anchor Rods S1-G1 & S2-A6

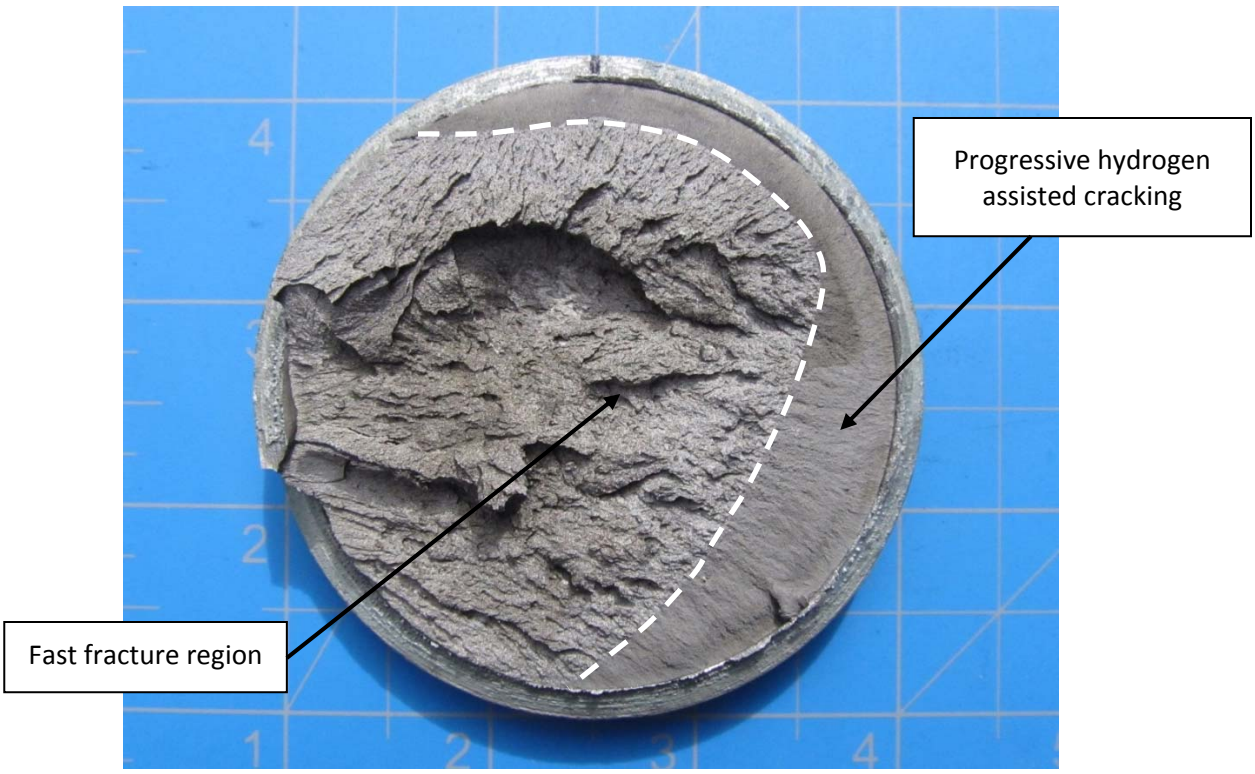
The overall appearance of both rod fractures was brittle (i.e., there was no thread elongation/stretching to suggest plastic deformation/yielding occurred prior to fracture). Photos 2-8 show the observed fracture features. There was evidence indicating that hydrogen assisted cracks were present in both rods prior to failure. The cracks initiated and extended from the thread root up to a depth of 0.6 inches in Rod S1-G1, and 0.4 inches in Rod S2-A6 (see Photos 4 and 8). The presence and appearance of the cracks, and the delayed nature of the fractures point to time dependence of the failure mechanism. Cracks developed and grew in both rods, which progressively exceeded their capacity with time, and resulted in final failure by fast fracture.

Photo 4) The fracture surface showing progressive hydrogen assisted cracking and fast fracture areas.

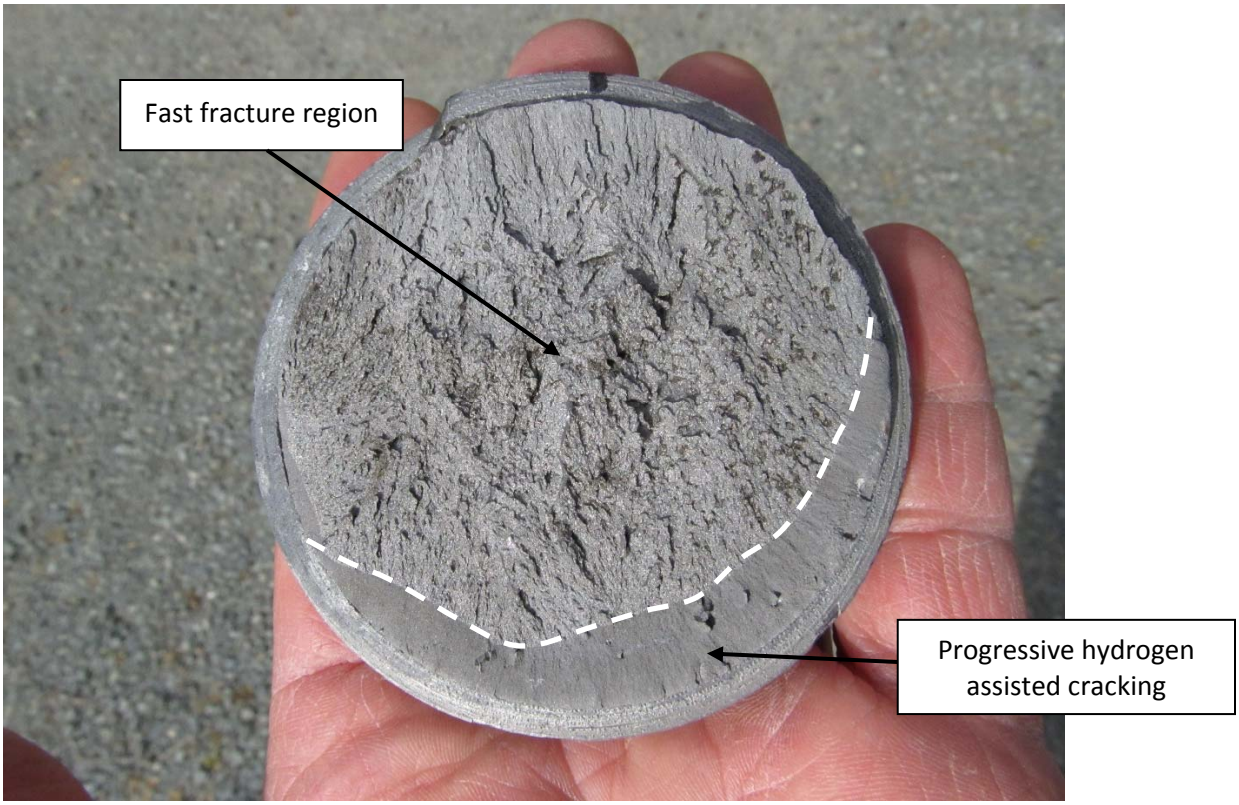
Photo 8) The fracture surface showing progressive hydrogen assisted cracking and fast fracture areas.

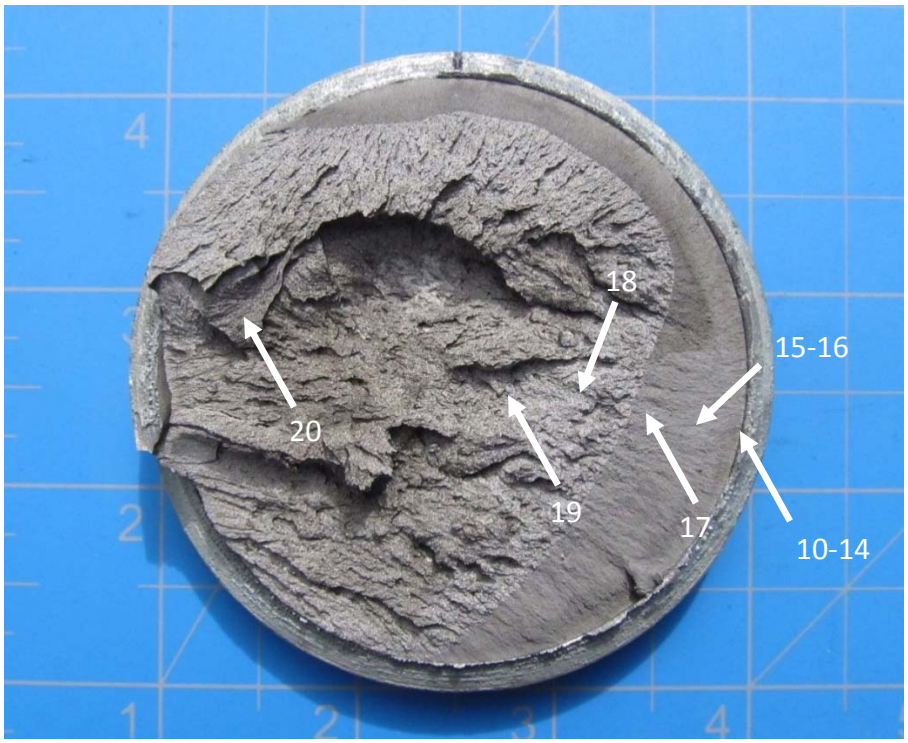
Photo 9) Fractured rod S1-G1 showing the locations of SEM photos 10-20.

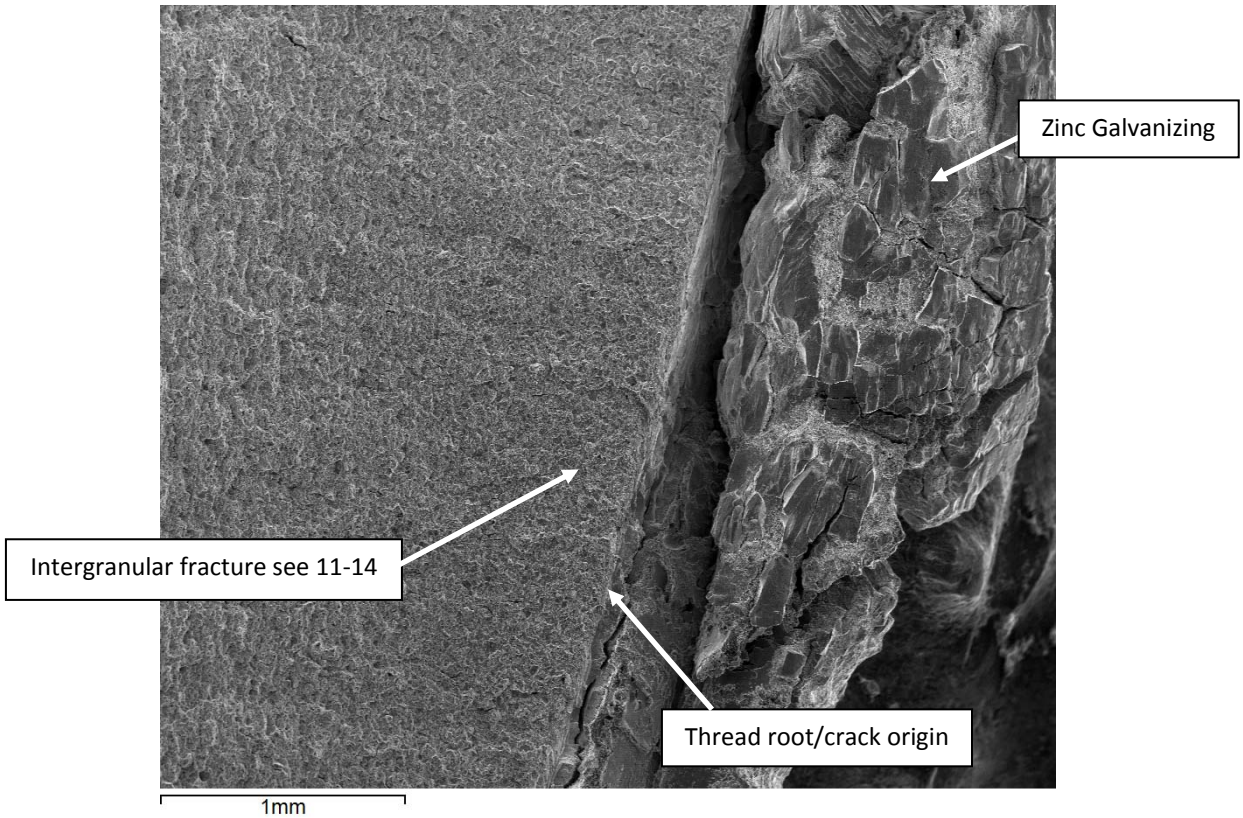
The fracture surfaces were examined at high magnification with a scanning electron microscope (SEM) to further characterize the failure mechanism. Intergranular fracture morphology was observed at, and near, the thread root (i.e., crack origin). See Photos 9-14. Intergranular cracking is a characteristic feature indicative of a number of brittle fracture mechanisms, including hydrogen assisted cracking. Intergranular features were predominant at the thread root (i.e., crack origin). Gradually increasing mixed morphology was observed as the crack progressively grew and extended inward from the thread root (i.e., more ductile tearing, and less intergranular features). See Photos 15-17. Sudden fast fracture occurred when the crack reached a critical size, wherein the reduced capacity of the rod could no longer sustain the applied load. The morphology across the final fast fracture zone was almost exclusively cleavage (brittle fracture mechanism). See Photos 18-20. This observation is considered unusual. Final rupture of bolts (in the strength range of A354 grade BD) caused by tensile overload following crack propagation typically occurs in ductile mode.

Photo 10) SEM image of S1-G1 at crack origin.

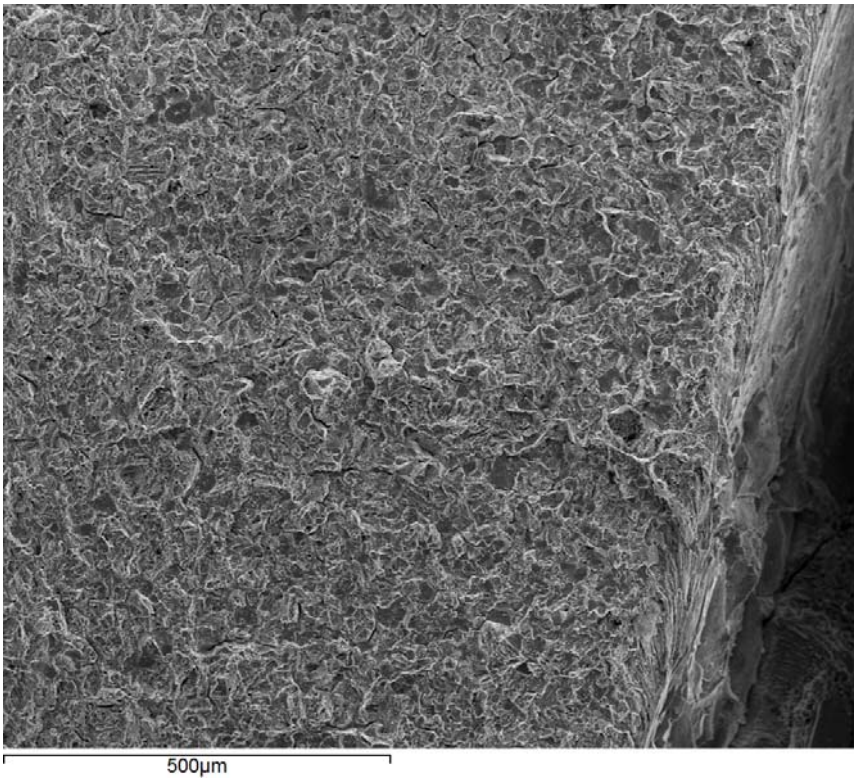
Photo 11) Same as Photo 10 except higher magnification.

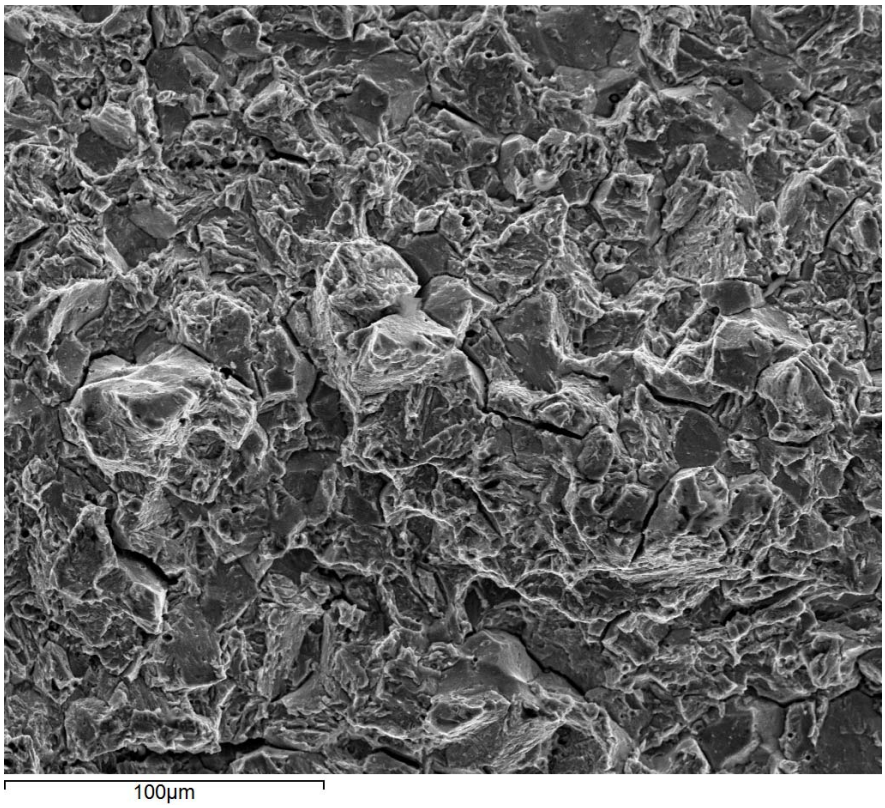
Photo 12) Same as Photo 11 except higher magnification.

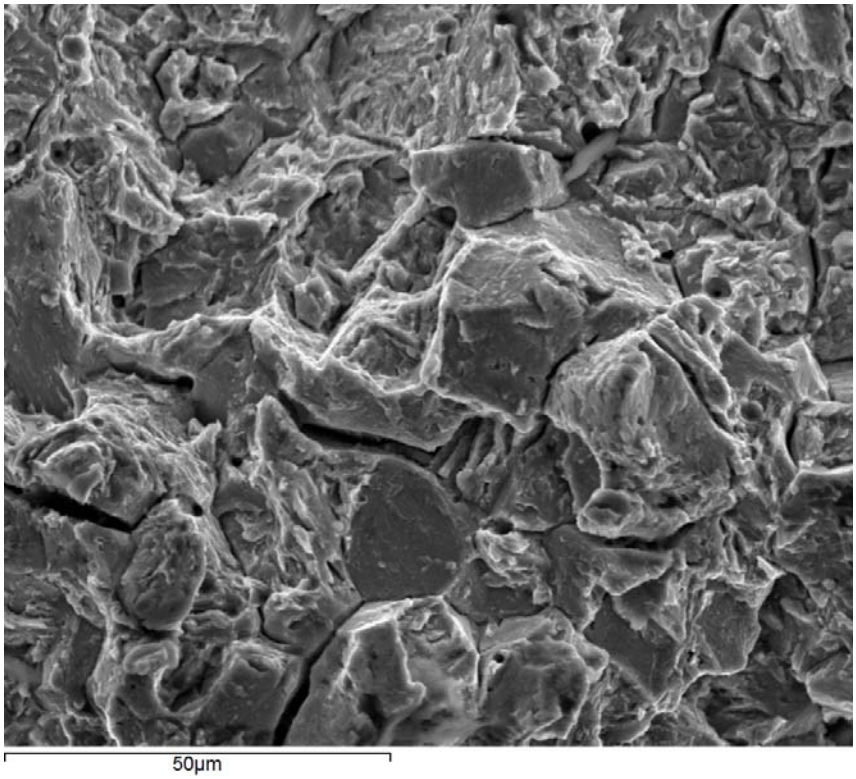
Photo 13) Same as Photo 12 except higher magnification showing intergranular fracture features.

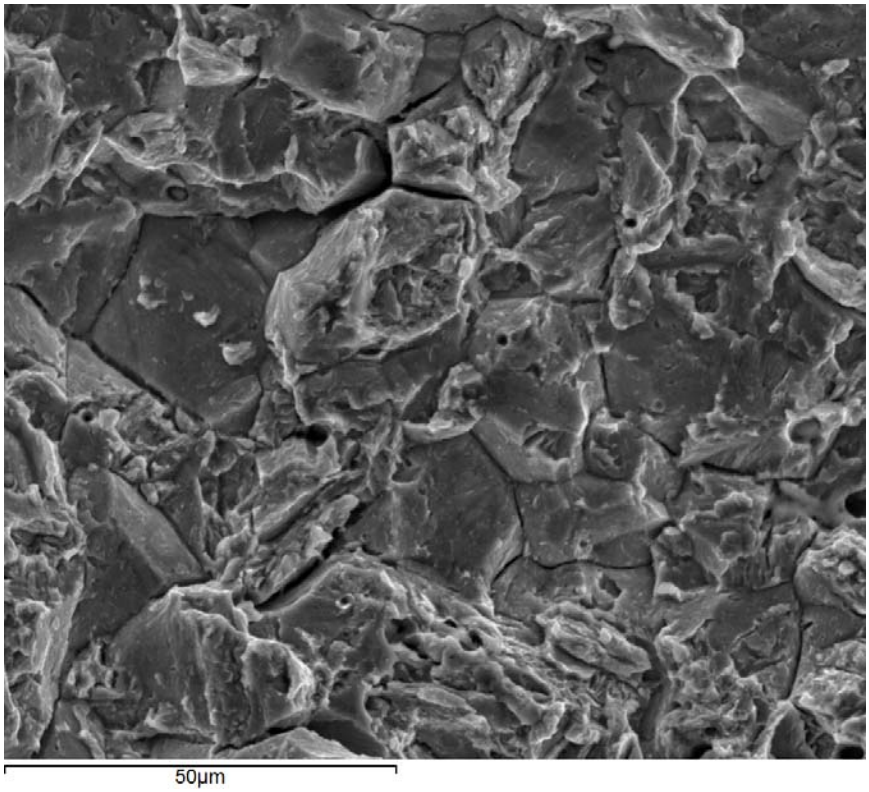
Photo 14) Same as Photo 11 except higher magnification showing more intergranular fracture features.

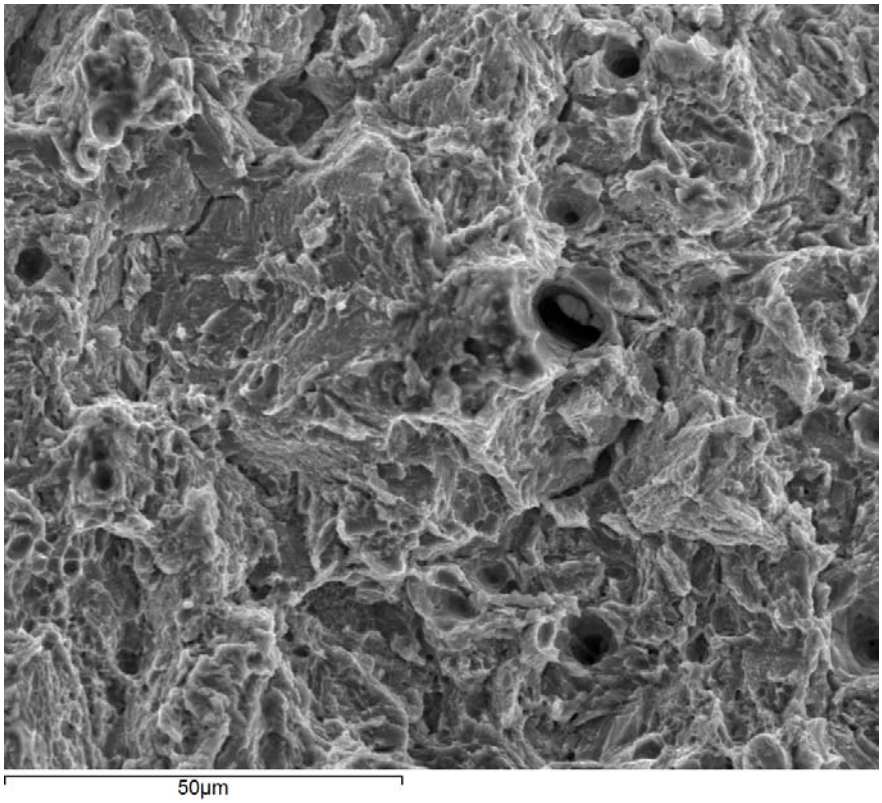
Photo 15) Mixed ductile tearing and intergranular fracture features.

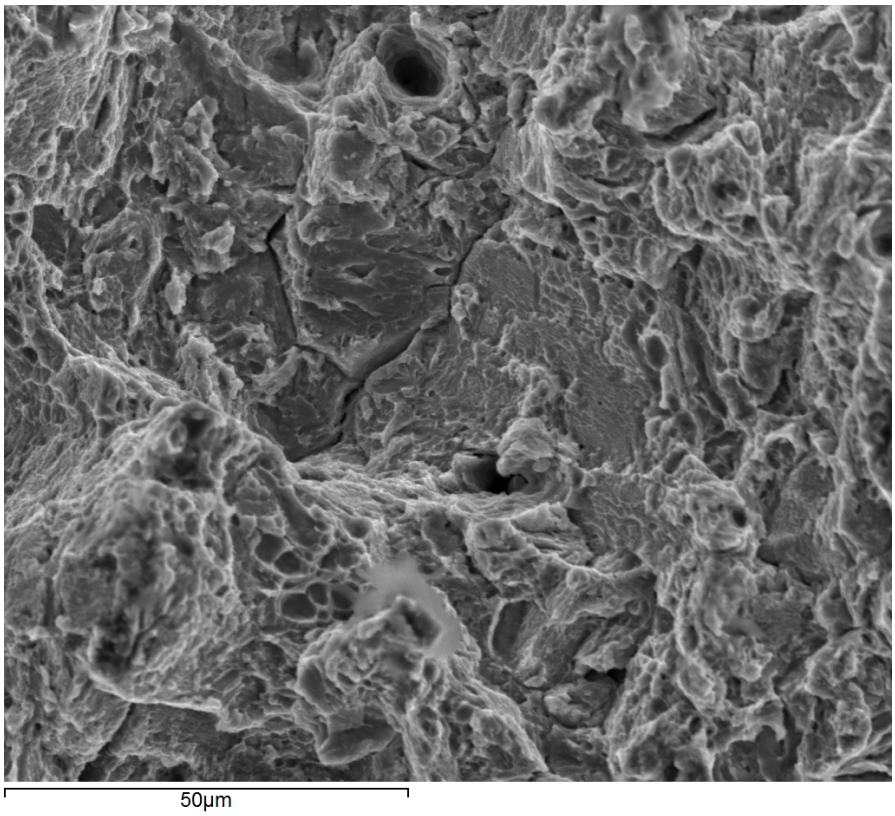
Photo 16) Mixed ductile tearing and intergranular fracture features.

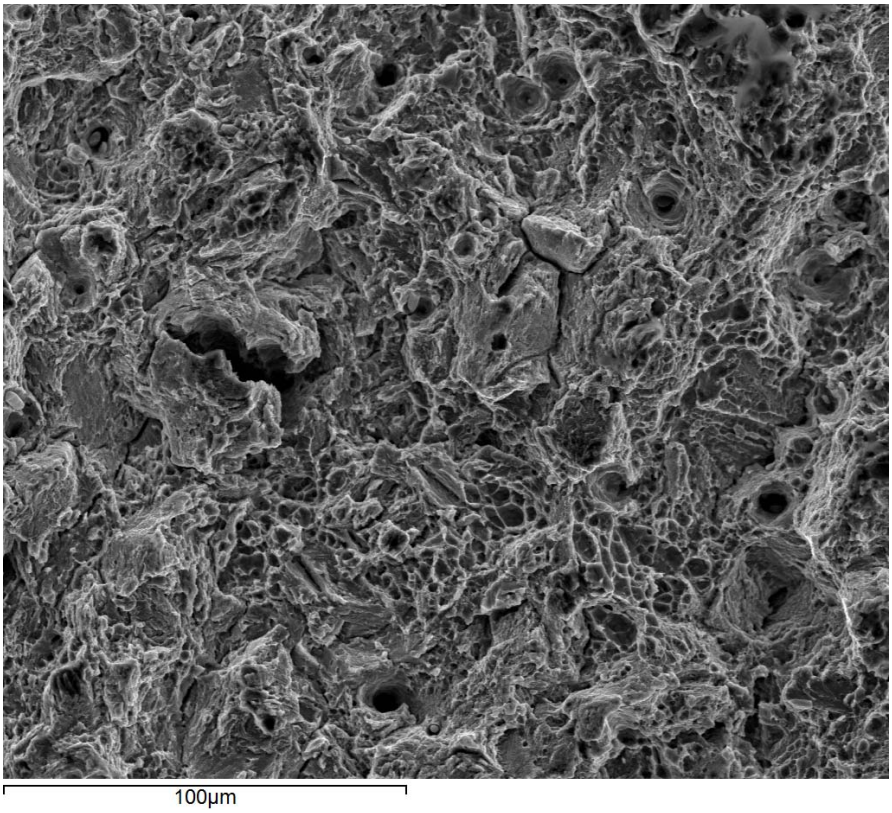
Photo 17) Mixed ductile tearing and intergranular fracture features.

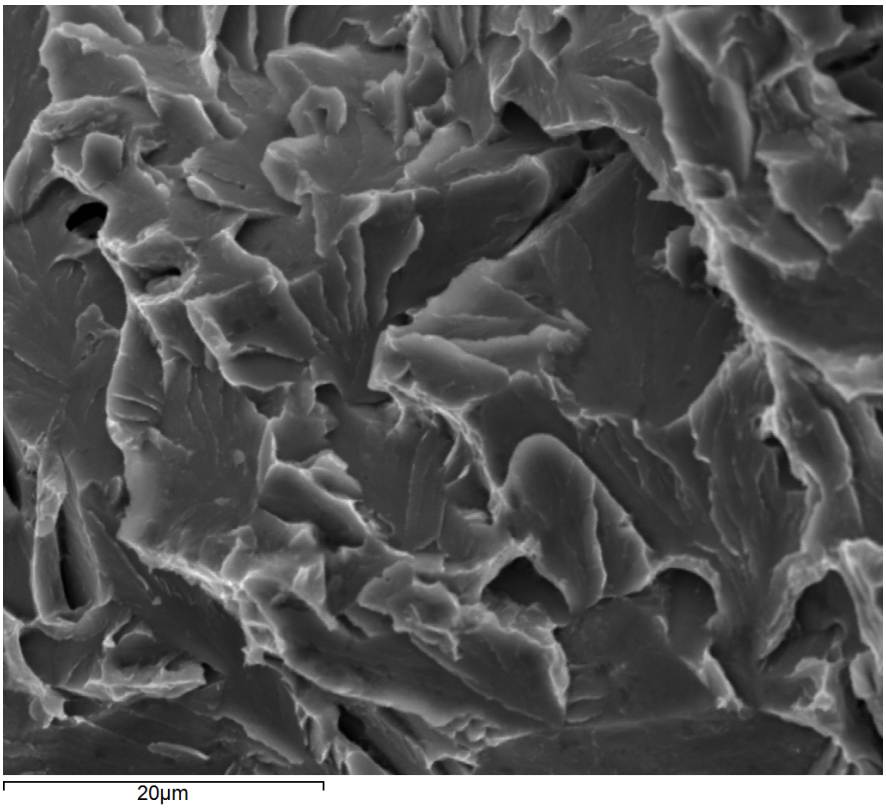
Photo 18) Cleavage fracture features – brittle fast fracture.

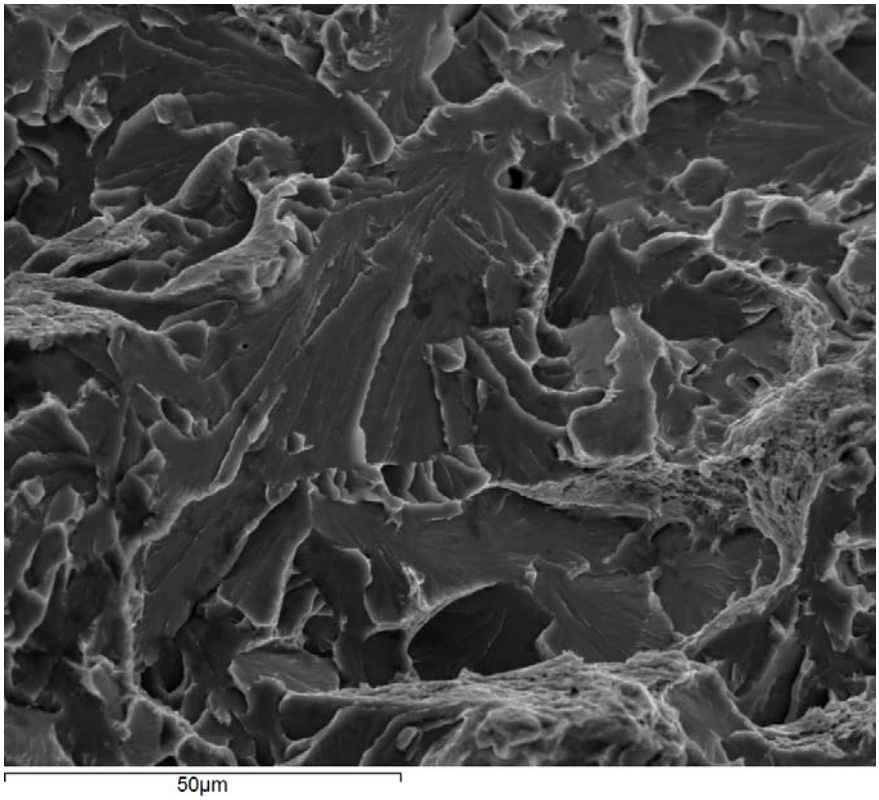
Photo 19) Cleavage fracture features – brittle fast fracture.

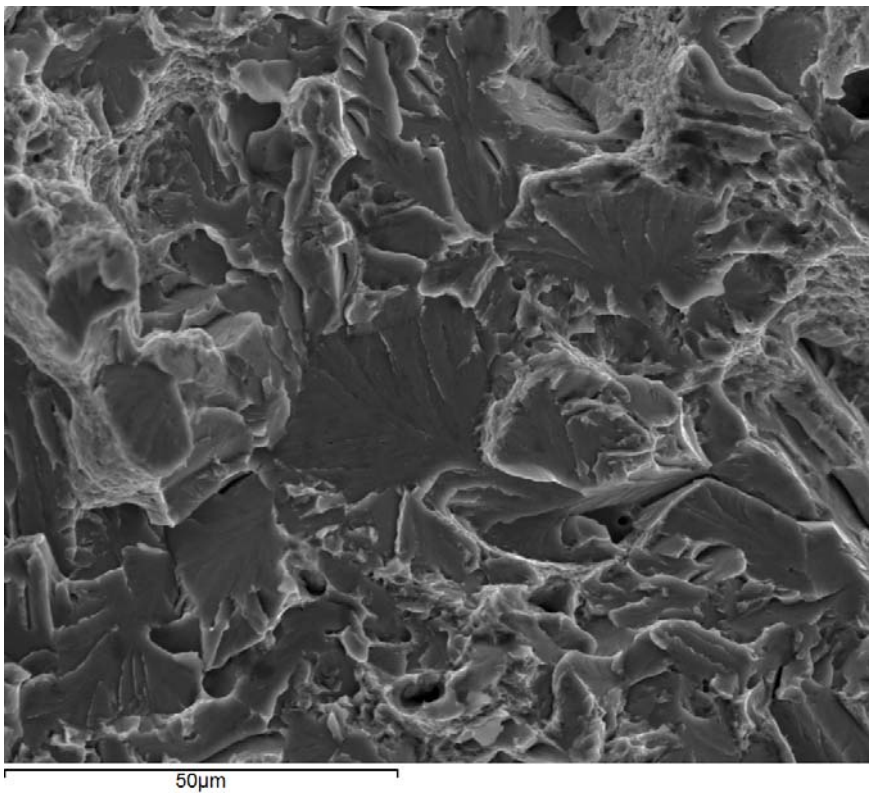
Photo 20) Cleavage fracture features – brittle fast fracture.

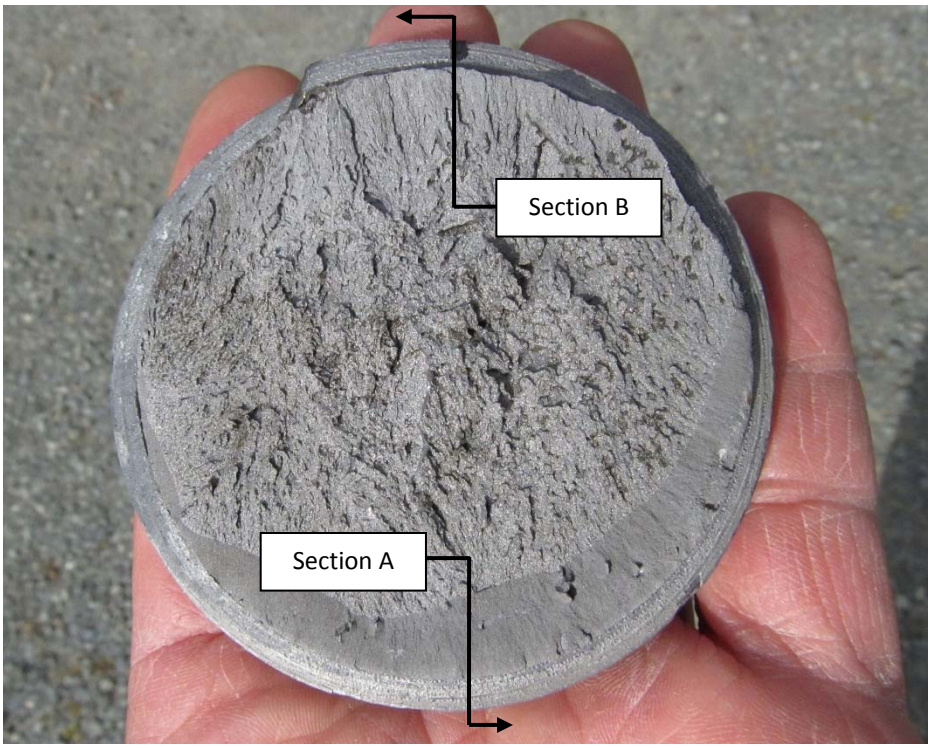
Cross-sections were cut from both rods and metallurgically prepared (i.e., mounted/potted, polished and etched). The location of the cross-sections is shown in Photos 21-22. The observed microstructure was generally tempered martensite, which is the normal structure associated with quenched and tempered AISI 4140 steel. However, many areas especially toward the center of the rod, showed evidence of incomplete martensitic transformation. The regions of incomplete transformation, as characterized by the observed presence of ferrite and pearlite, appeared to alternate in banded layers between regions of fully transformed martensitic structure. The banded nature of the microstructure is an indication that the material is not homogeneous. See Photos 23-26. Additionally, there was a relatively high amount of non-metallic stringer inclusions present in the microstructure. See Photos 27 and 28.

Photo 21) Fractured rod S2-A6 showing the location of cross-sections for microstructural examination and microhardness tests.

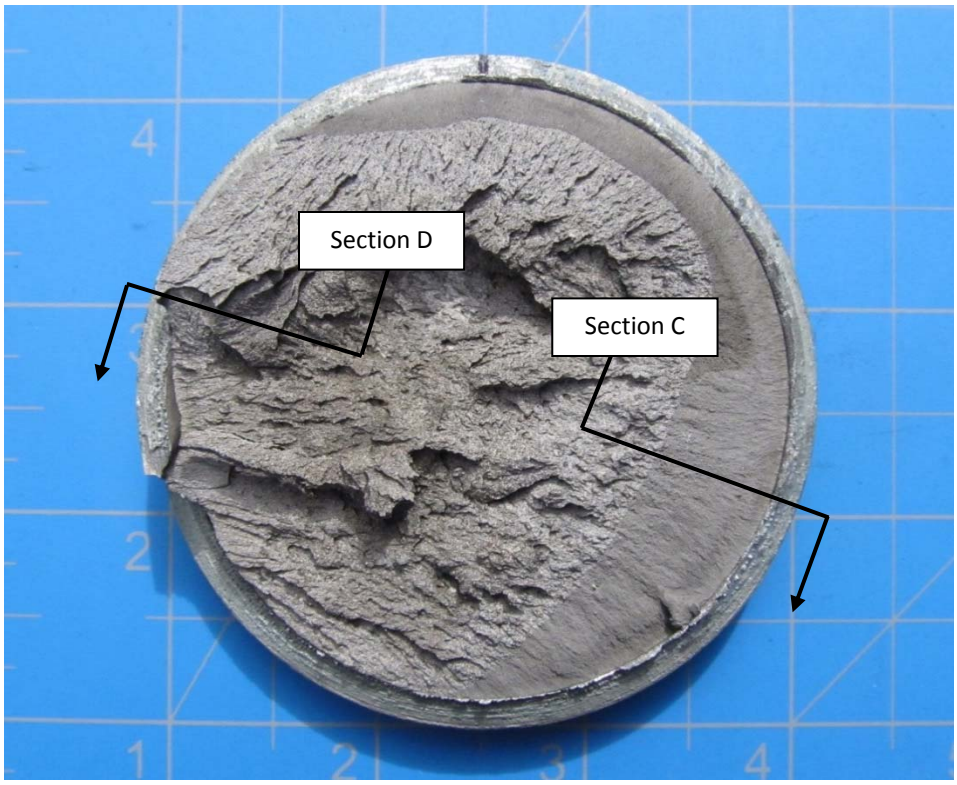
Photo 22) Fractured rod S1-G1 showing the location of cross-sections for microstructural examination and microhardness tests.

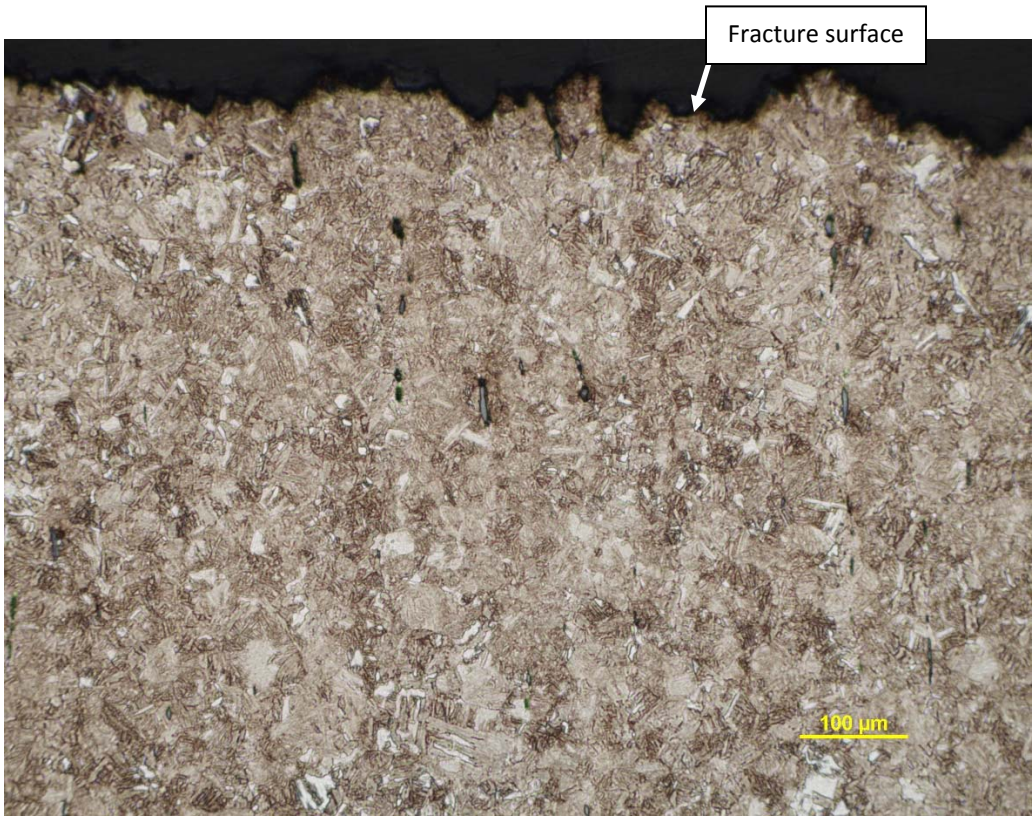
Photo 23) Example of microstructure observed in S2-A6 at Section A. (Etchant 2%Nital)

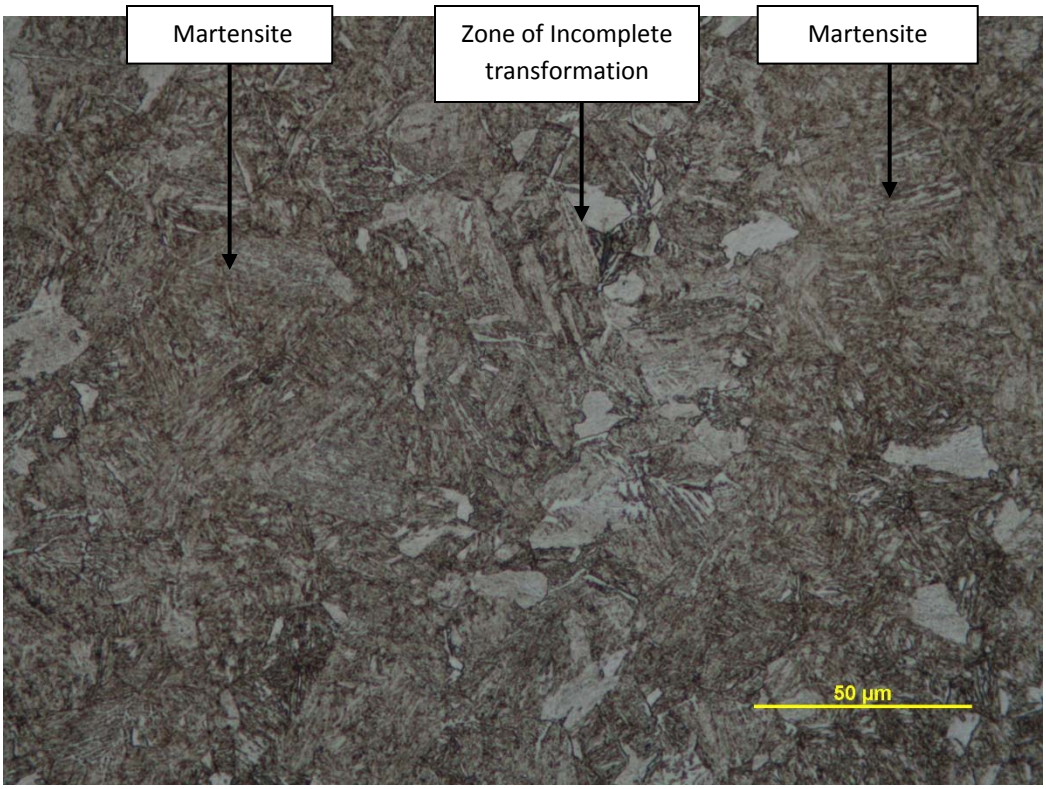
Photo 24) Same as above except higher magnification. Note the structure is not fully tempered martensite. The center region did not fully transformed to martensite.

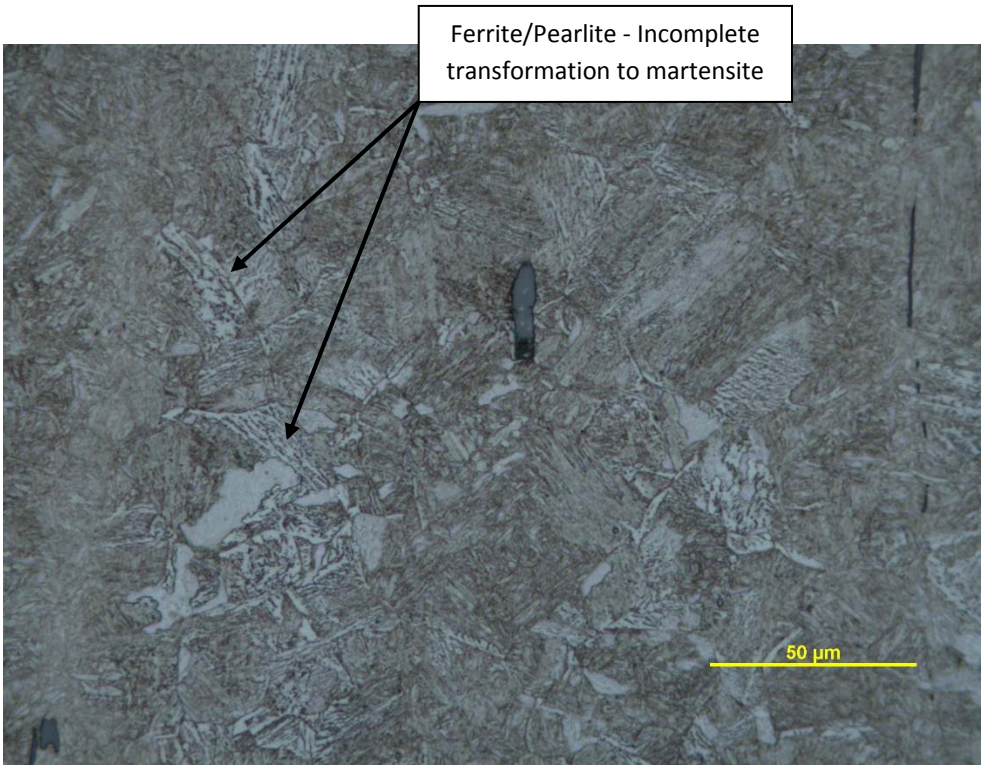
Photo 26) Same as above except higher magnification. Note ferrite/pearlite where the structure is not fully tempered martensite. (Etchant: 2% Nital)

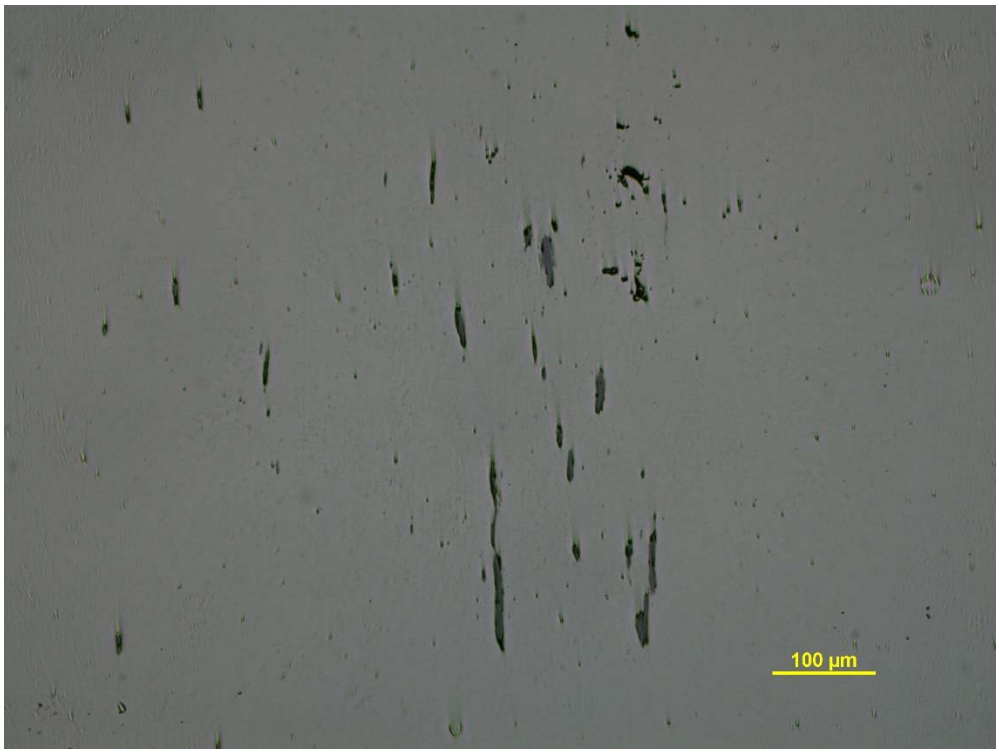
Photo 27) Example of stringer inclusions observed in microstructure. (Unetched)

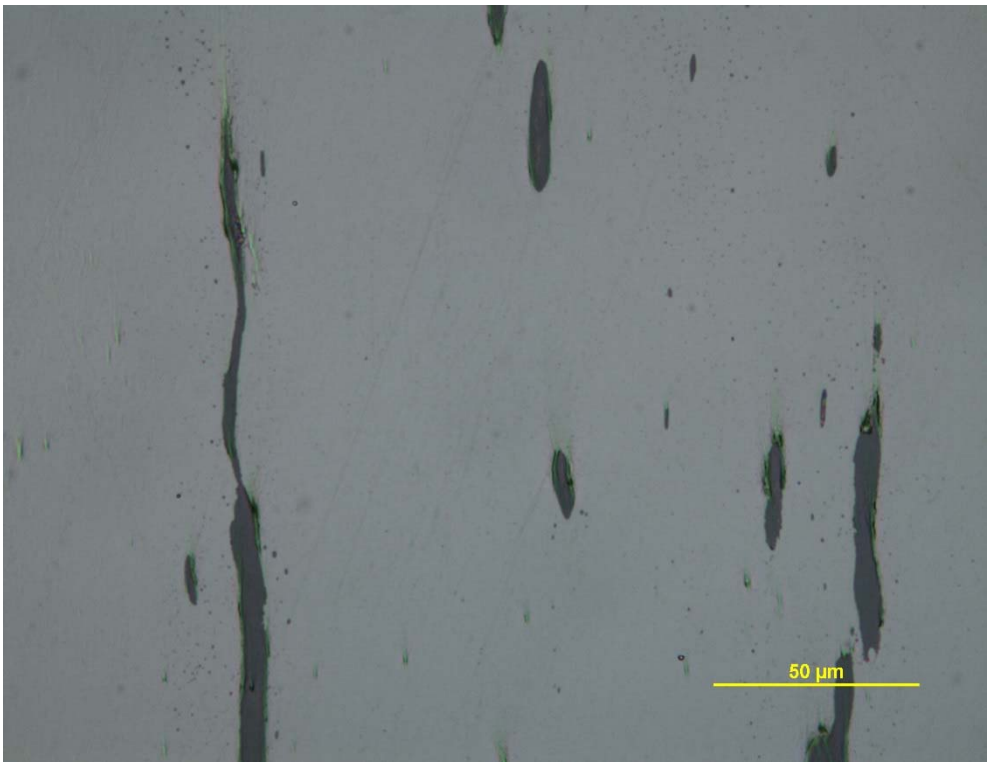
Photo 28) Same as Photo 28 except higher magnification of non-metallic stringer inclusions.

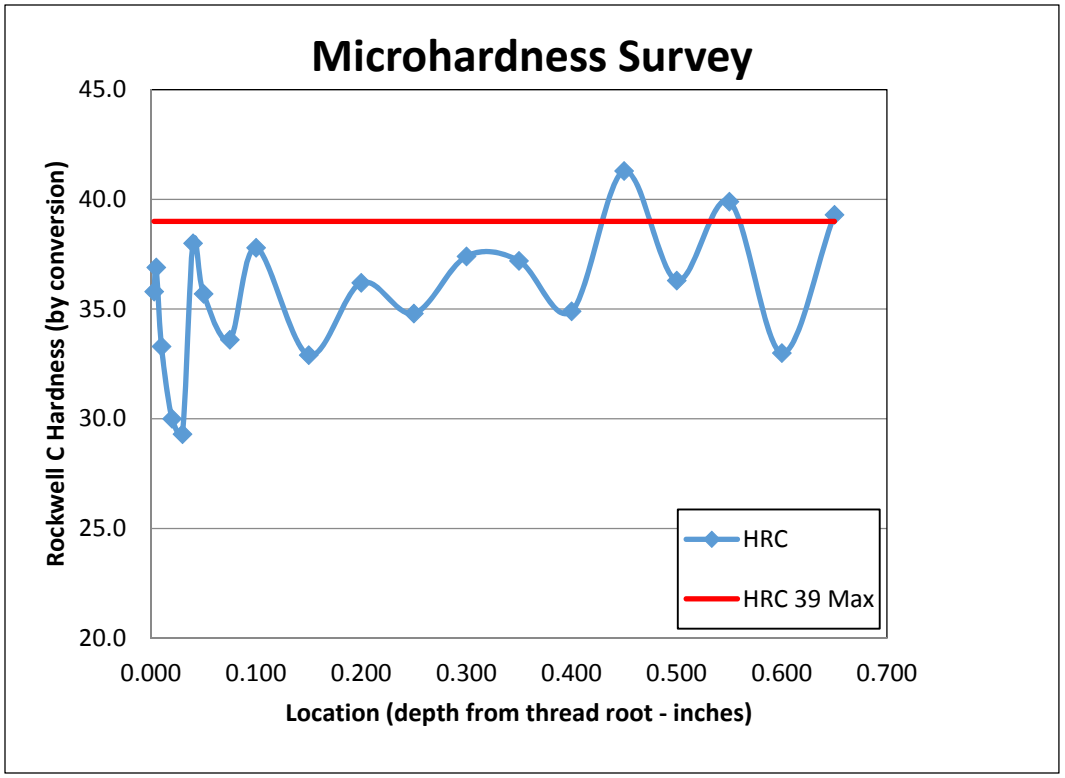
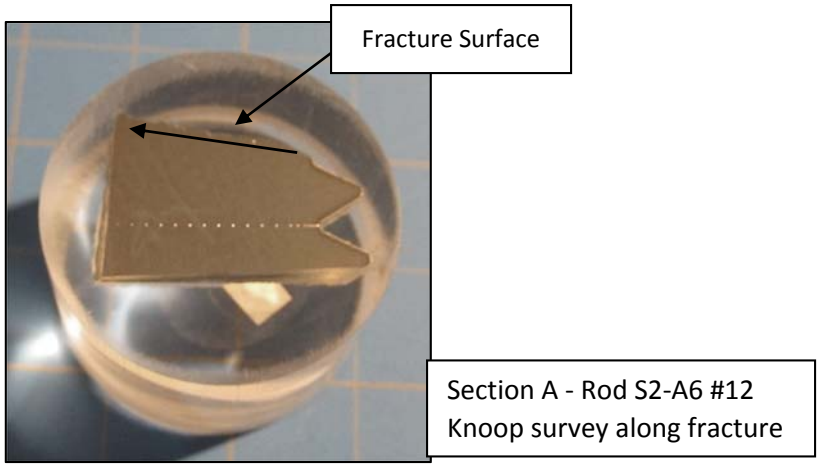
Figure A1
(Rod S2-A6 Section A)

The general trend of the microhardness results indicates repeated microstructural regions with local hardness exceeding the maximum bulk hardness of 39 HRC that is specified in ASTM A354 for grade BD (39 HRC is equivalent to 390 KHN).

Table 1 Knoop Microhardness Results		
Location Depth from surface (in.)	**Knoop Hardness Number**	**HRC (by conversion table)**
0.003	358	35.8
0.005	369	36.9
0.010	336	33.3
0.020	311	30.0
0.030	306	29.3
0.040	380	38.0
0.050	357	35.7
0.075	339	33.6
0.100	378	37.8
0.150	333	32.9
0.200	362	36.2
0.250	349	34.8
0.300	374	37.4
0.350	372	37.2
0.400	350	34.9
0.450	418	41.3
0.500	363	36.3
0.550	401	39.9
0.600	334	33.0
0.650	**394**	**39.3**

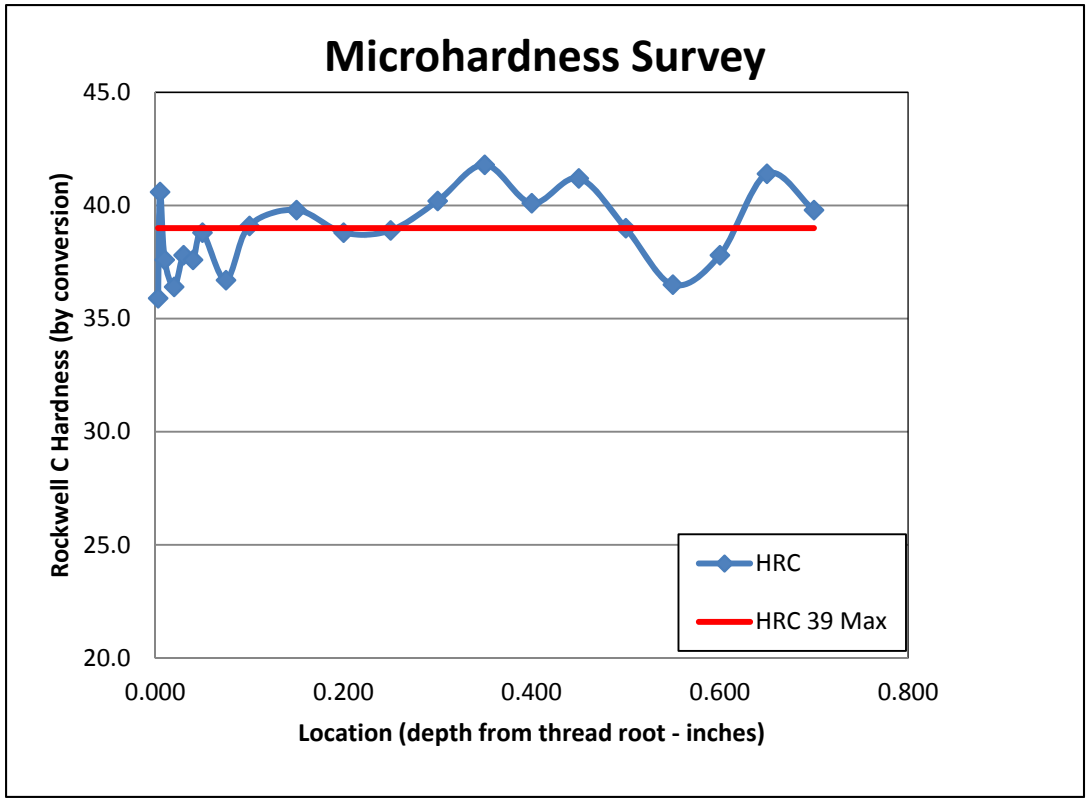
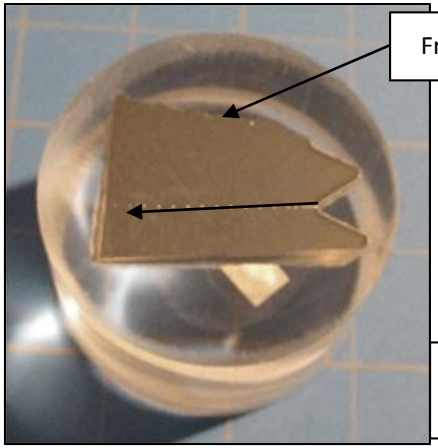
Figure A2
(Rod S2-A6 Section A)

Table 2 Knoop Microhardness Results		
Location Depth from surface (in.)	Knoop Hardness Number	HRC (by conversion table)
0.003	359	35.9
0.005	409	40.6
0.010	376	37.6
0.020	364	36.4
0.030	378	37.8
0.040	376	37.6
0.050	387	38.8
0.075	367	36.7
0.100	392	39.1
0.150	399	39.8
0.200	387	38.8
0.250	390	38.9
0.300	405	40.2
0.350	423	41.8
0.400	403	40.1
0.450	417	41.2
0.500	391	39.0
0.550	365	36.5
0.600	378	37.8
0.650	419	41.4
0.700	400	39.8

Section A - Rod S2-A6
Knoop survey from thread root

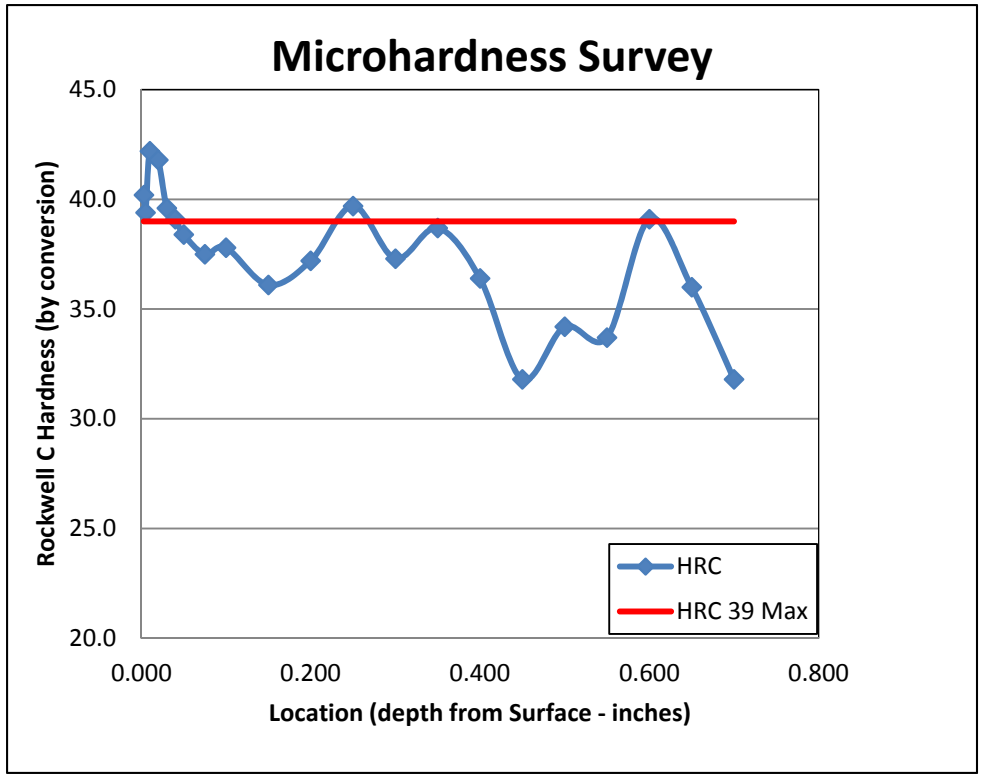
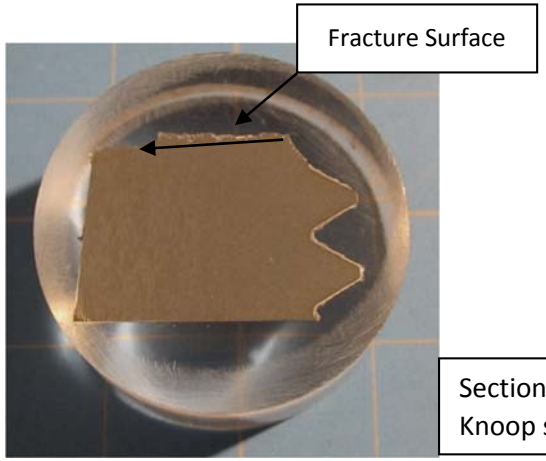
Figure A3
(Rod S2-A6 Section B)

Table 3 Knoop Microhardness Results		
Location Depth from surface (in.)	Knoop Hardness Number	HRC (by conversion table)
0.003	404	40.2
0.005	395	39.4
0.010	429	42.2
0.020	423	41.8
0.030	397	39.6
0.040	392	39.1
0.050	384	38.4
0.075	375	37.5
0.100	378	37.8
0.150	361	36.1
0.200	372	37.2
0.250	399	39.7
0.300	373	37.3
0.350	387	38.7
0.400	364	36.4
0.450	324	31.8
0.500	344	34.2
0.550	339	33.7
0.600	392	39.1
0.650	360	36.0
0.700	324	31.8

Section B - Rod S2-A6
Knoop survey along fracture

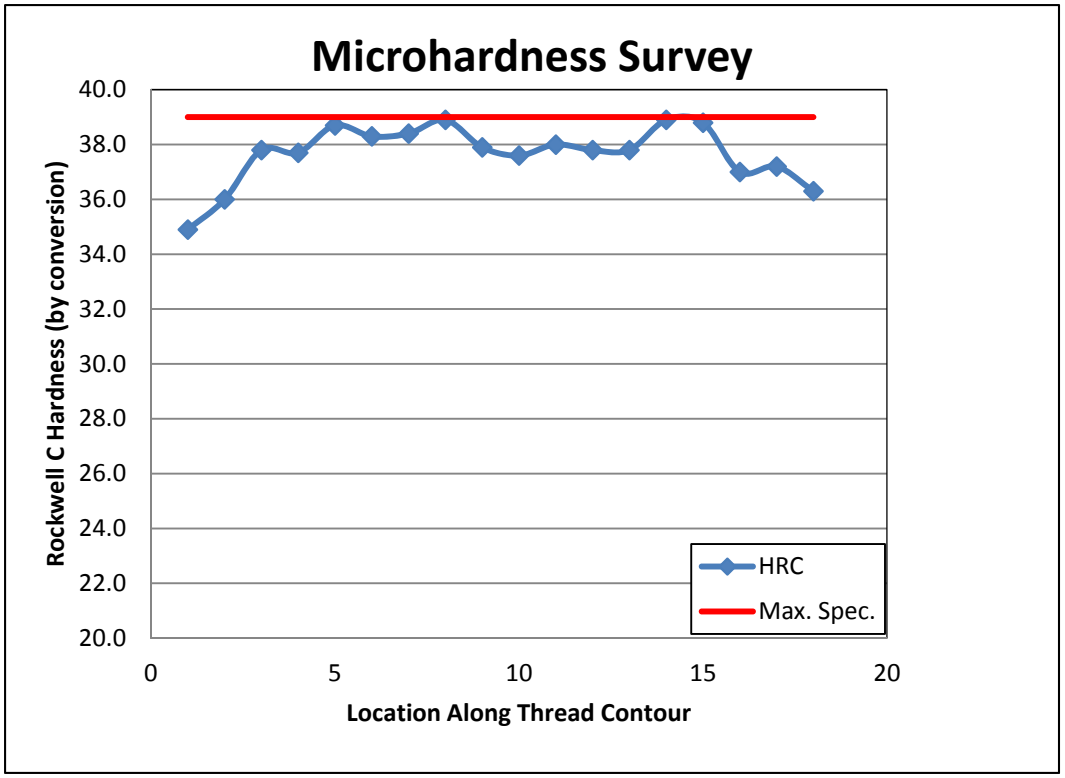
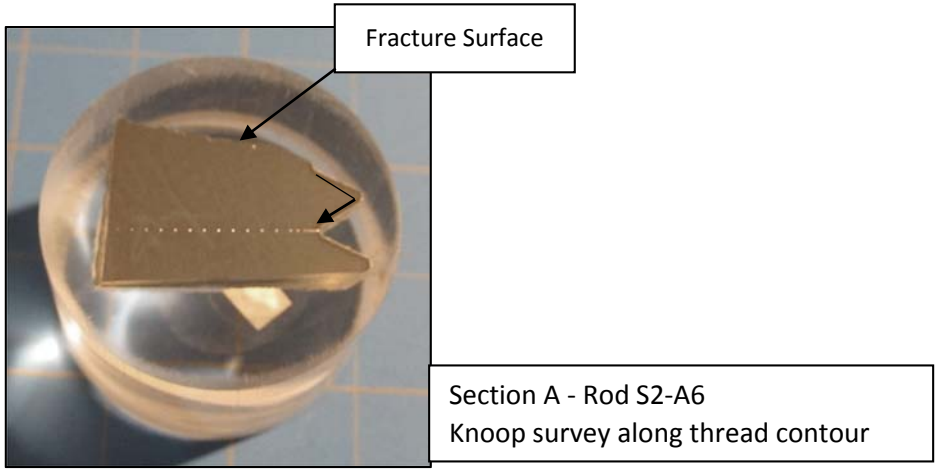
Figure A4
(Rod S2-A6 Section A)

Table 4 Knoop Microhardness Results		
Location Depth from surface (in.)	Knoop Hardness Number	HRC (by conversion table)
1	350	34.9
2	360	36.0
3	378	37.8
4	377	37.7
5	387	38.7
6	383	38.3
7	384	38.4
8	390	38.9
9	379	37.9
10	376	37.6
11	380	38.0
12	378	37.8
13	378	37.8
14	390	38.9
15	389	38.8
16	370	37.0
17	372	37.2
18	363	36.3
