Project# 04-0120F4

Metallurgical Analysis of Bay Bridge Broken Anchor Rods S1-G1 & S2-A6

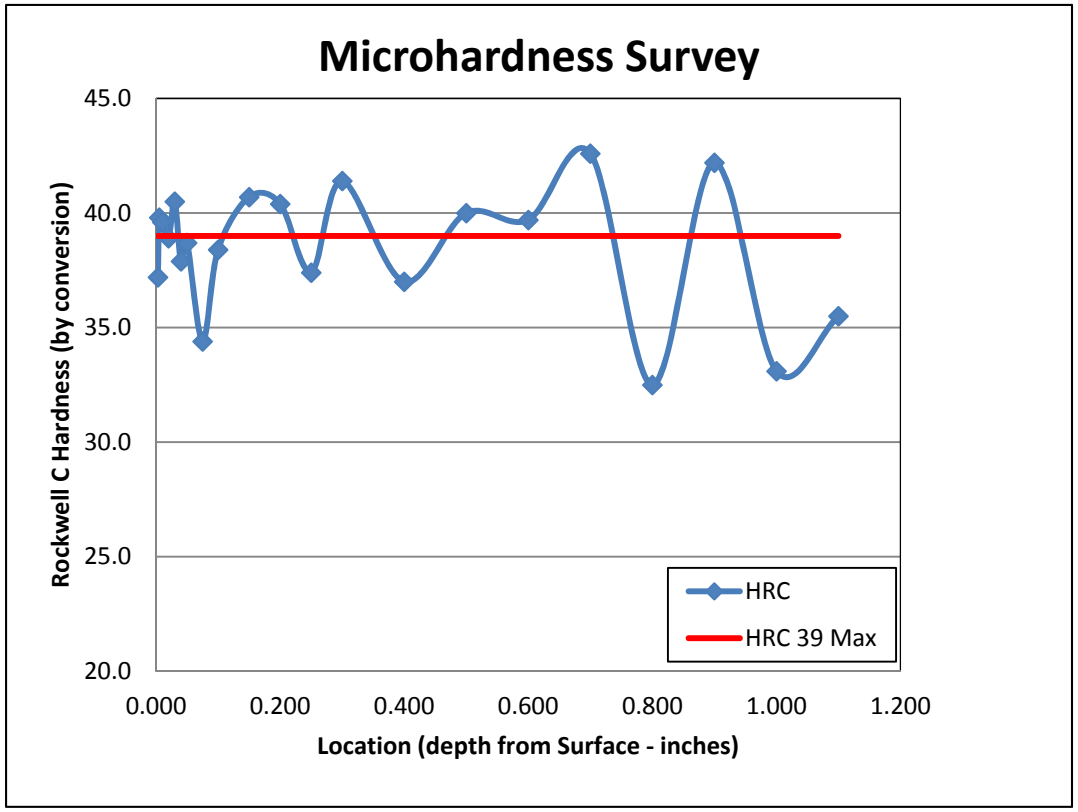
Figure A5
(Rod S2-A6 #12)

Table 5 Knoop Microhardness Results		
Location Depth from surface (in.)	Knoop Hardness Number	HRC (by conversion table)
0.003	372	37.2
0.005	400	39.8
0.010	397	39.6
0.020	390	38.9
0.030	408	40.5
0.040	379	37.9
0.050	389	38.7
0.075	346	34.4
0.100	384	38.4
0.150	410	40.7
0.200	407	40.4
0.250	374	37.4
0.300	419	41.4
0.400	370	37.0
0.500	402	40.0
0.600	398	39.7
0.700	433	42.6
0.800	330	32.5
0.900	428	42.2
1.000	335	33.1
1.100	355	35.5

Rod S2-A6 #12
Readings taken radially inward from the thread root at a location approximately ¾ inch from the fracture.

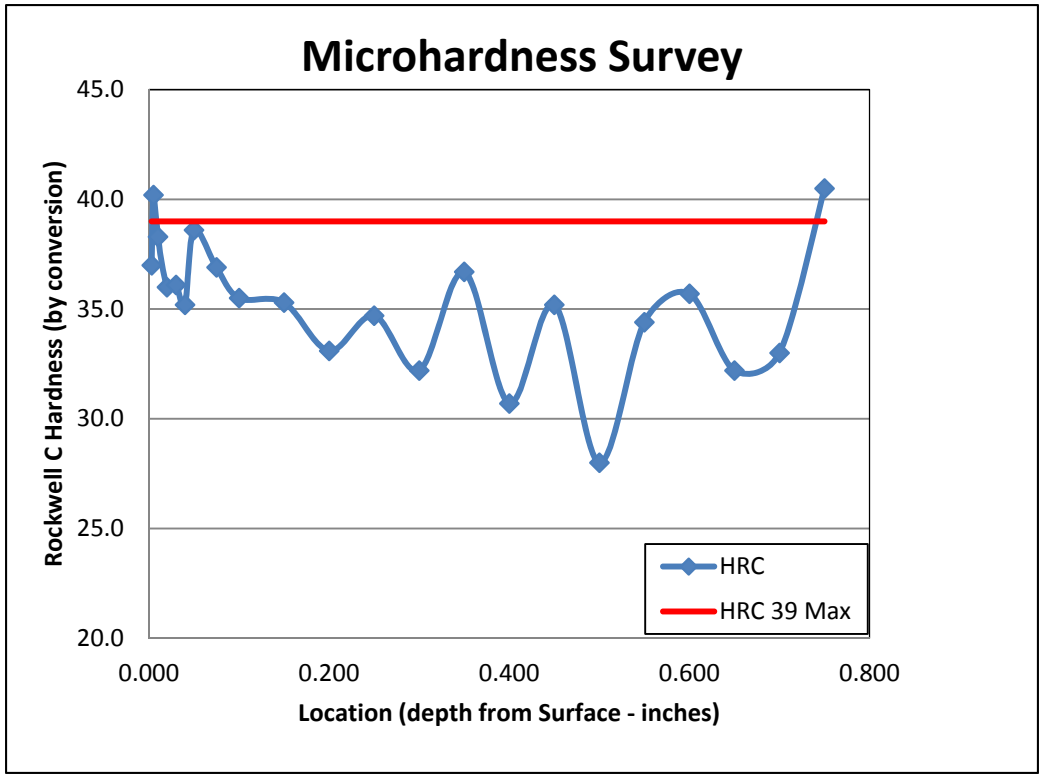
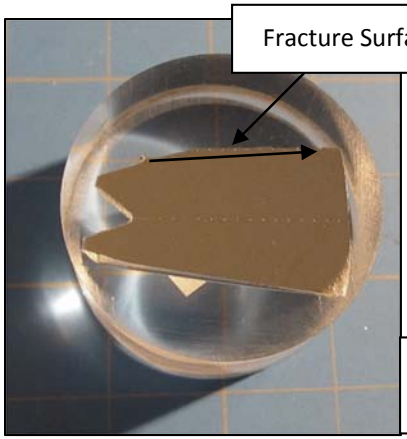
Figure A6
(Rod S1-G1 Section C)

Table 6 Knoop Microhardness Results		
Location Depth from surface (in.)	Knoop Hardness Number	HRC (by conversion table)
0.003	370	37.0
0.005	404	40.2
0.010	383	38.3
0.020	360	36.0
0.030	361	36.1
0.040	353	35.2
0.050	386	38.6
0.075	369	36.9
0.100	356	35.5
0.150	354	35.3
0.200	335	33.1
0.250	348	34.7
0.300	328	32.2
0.350	367	36.7
0.400	316	30.7
0.450	353	35.2
0.500	297	28.0
0.550	346	34.4
0.600	357	35.7
0.650	328	32.2
0.700	334	33.0
0.750	407	40.5

Section C - Rod S1-G1 #11
Knoop survey along fracture

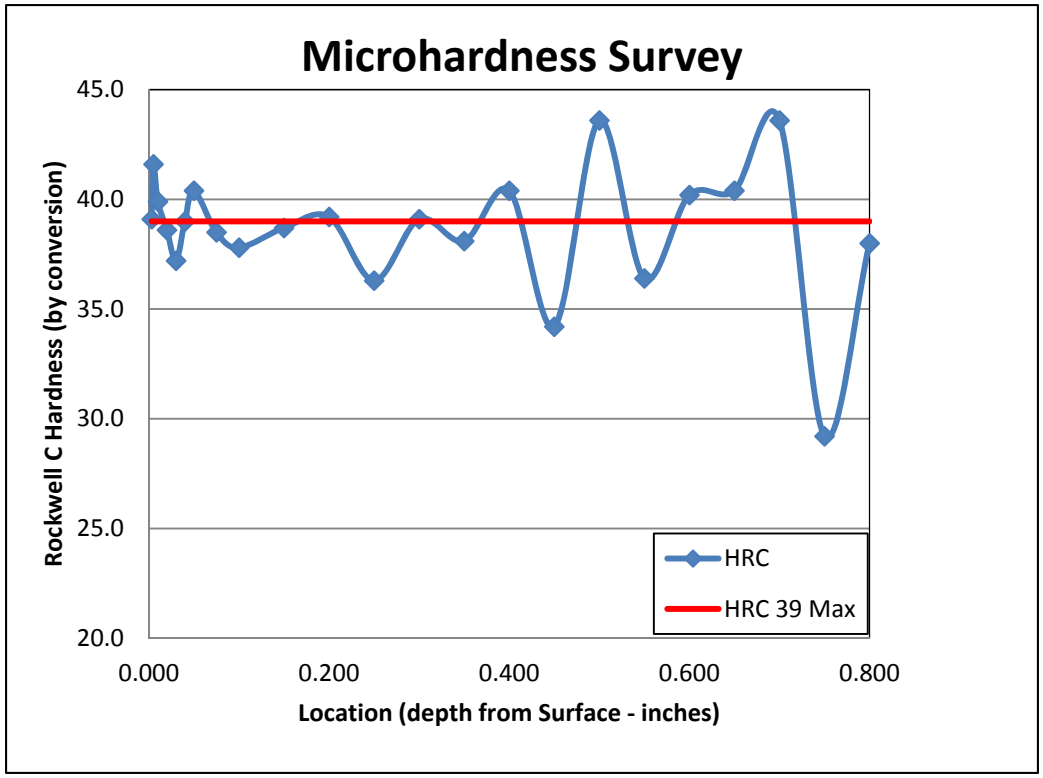
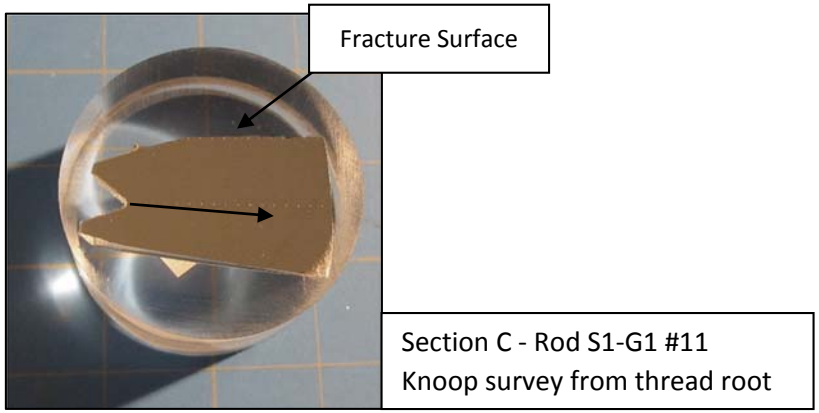
Figure A7
(Rod S1-G1 Section C)

Table 7 Knoop Microhardness Results		
Location Depth from surface (in.)	Knoop Hardness Number	HRC (by conversion table)
0.003	392	39.1
0.005	421	41.6
0.010	369	39.9
0.020	386	38.6
0.030	372	37.2
0.040	391	39.0
0.050	407	40.4
0.075	386	38.5
0.100	378	37.8
0.150	387	38.7
0.200	393	39.2
0.250	363	36.3
0.300	392	39.1
0.350	381	38.1
0.400	407	40.4
0.450	344	34.2
0.500	446	43.6
0.550	364	36.4
0.600	404	40.2
0.650	407	40.4
0.700	446	43.6
0.750	306	29.2
0.800	380	38.0

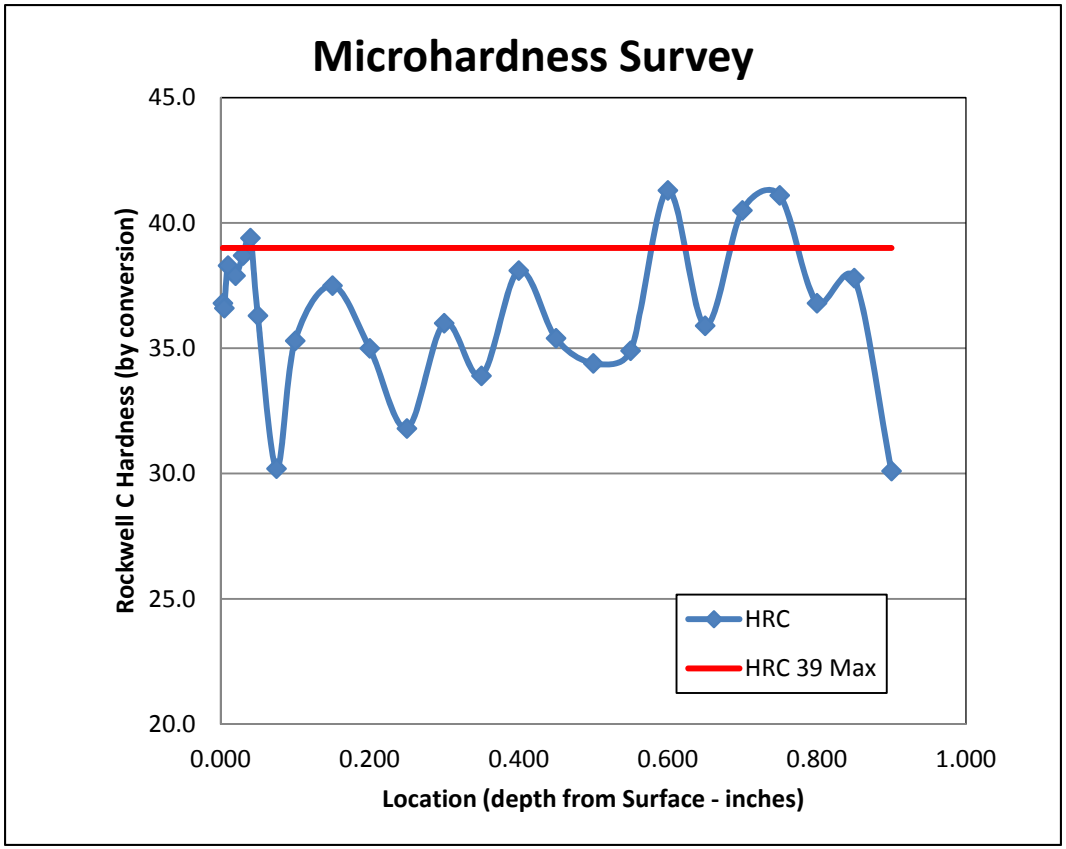
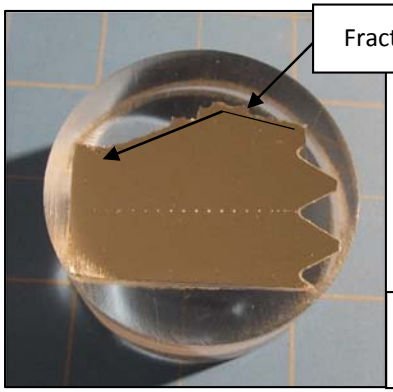
Figure A8
(Rod S1-G1 Section D)

Table 8 Knoop Microhardness Results		
Location Depth from surface (in.)	Knoop Hardness Number	HRC (by conversion table)
0.003	368	36.8
0.005	366	36.6
0.010	383	38.3
0.020	379	37.9
0.030	387	38.7
0.040	395	39.4
0.050	363	36.3
0.075	313	30.2
0.100	354	35.3
0.150	375	37.5
0.200	351	35.0
0.250	324	31.8
0.300	360	36.0
0.350	341	33.9
0.400	381	38.1
0.450	355	35.4
0.500	346	34.4
0.550	350	34.9
0.600	417	41.3
0.650	357	35.9
0.700	408	40.5
0.750	415	41.1
0.800	368	36.8
0.850	378	37.8
0.900	312	30.1

Section D - Rod S1-G1 #11
Knoop survey along fracture

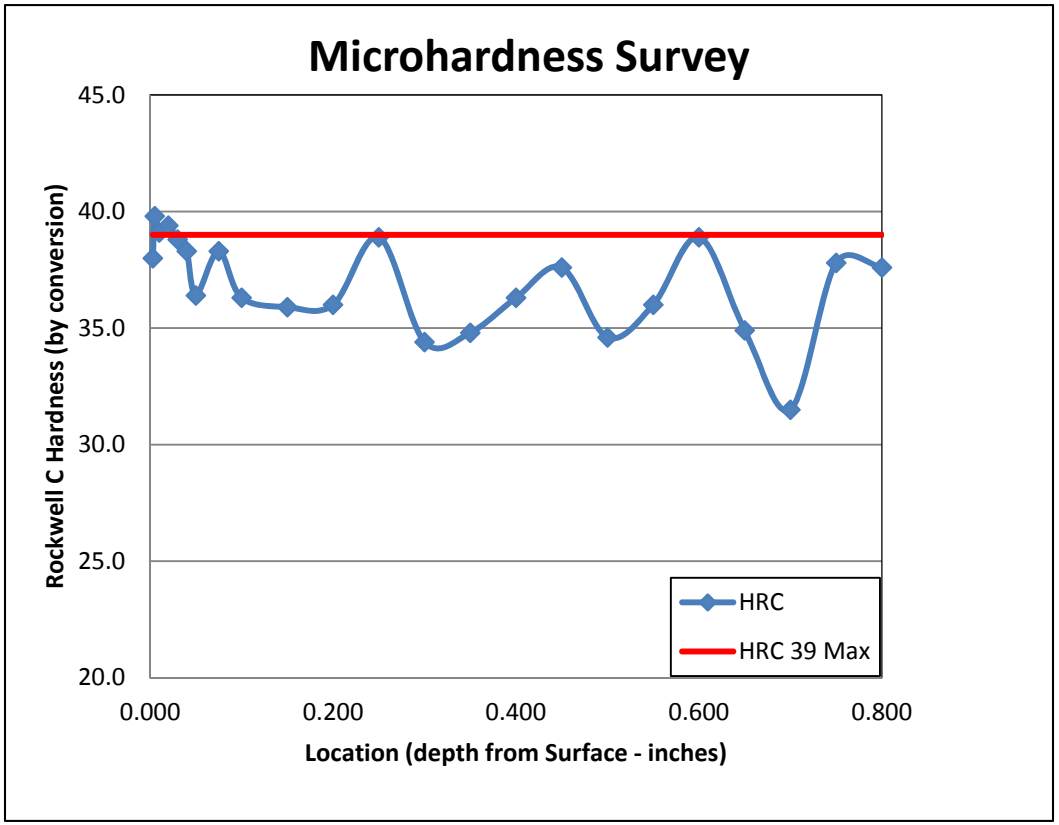
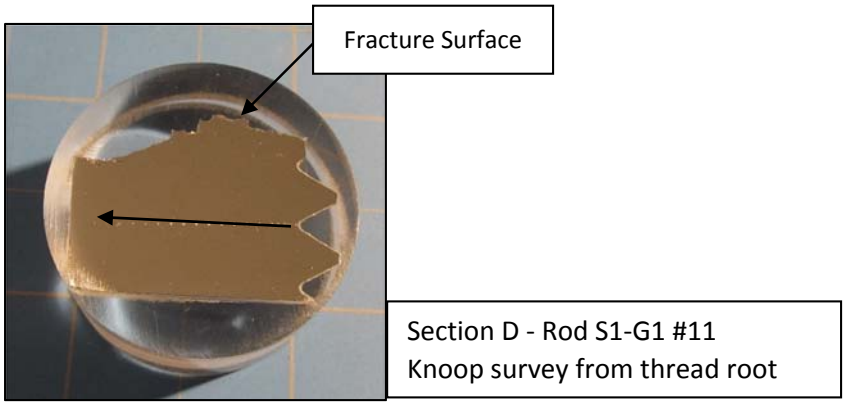
Figure A9
(Rod S1-G1 Section D)

Table 9 Knoop Microhardness Results		
Location Depth from surface (in.)	Knoop Hardness Number	HRC (by conversion table)
0.003	380	38.0
0.005	399	39.8
0.010	392	39.1
0.020	395	39.4
0.030	388	38.8
0.040	383	38.3
0.050	364	36.4
0.075	383	38.3
0.100	363	36.3
0.150	359	35.9
0.200	360	36.0
0.250	390	38.9
0.300	346	34.4
0.350	349	34.8
0.400	363	36.3
0.450	376	37.6
0.500	347	34.6
0.550	360	36.0
0.600	389	38.9
0.650	350	34.9
0.700	321	31.5
0.750	378	37.8
0.800	376	37.6

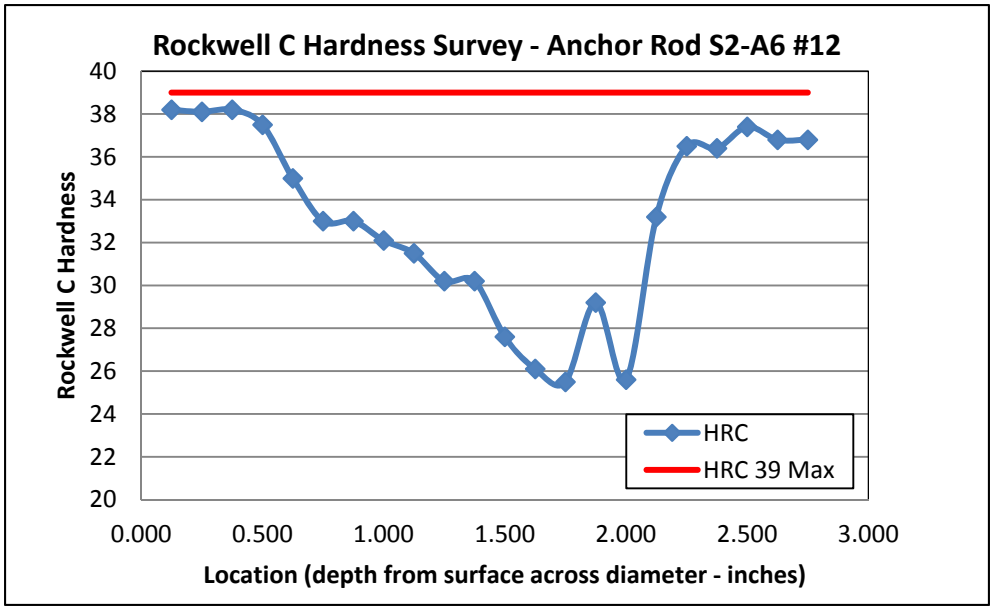
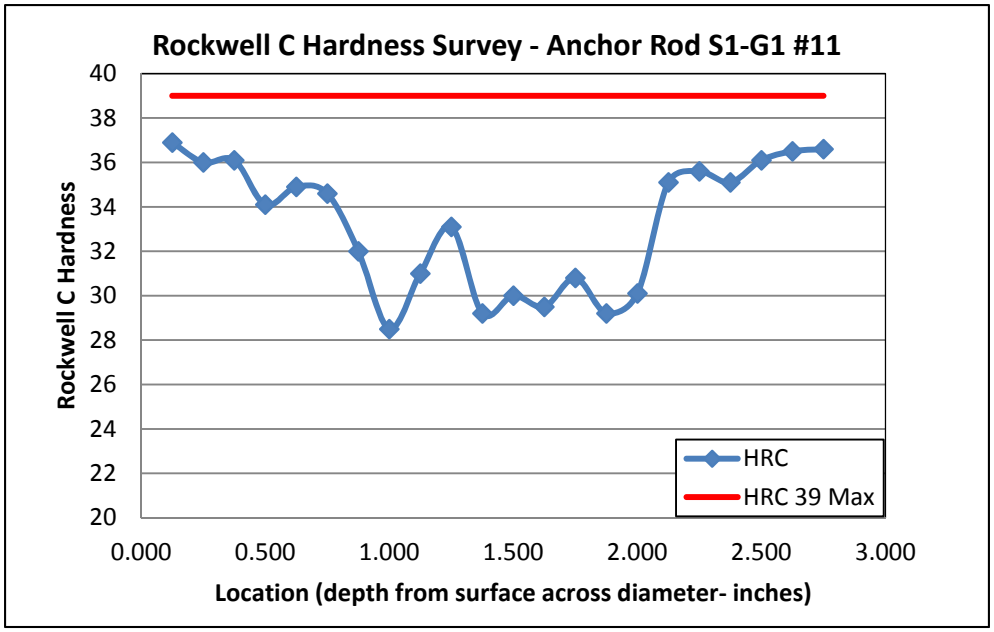
Rockwell C hardness measurements were made across the diameter and at mid-radius locations of both rods. The Rockwell hardness tests were performed by Anamet Inc. and their test reports are provided in Appendix B (see also plotted results in Figure A10 of Appendix A). The results of the Rockwell hardness test show variation in hardness, with the outer diameter approaching HRC 39. The center hardness drops to as low as HRC 25 indicating the material was not uniformly through-hardened. Completely uniform through-hardening is difficult to achieve in large diameter rods such as this case, however, the large disparity in hardness from center to edge indicates that the steel may not have had optimal through thickness hardenability or was improperly heat treated.

Rockwell C Hardness Across the Rod Diameter
