Briefing on E2 Anchor Bolts – April 24, 2013

THE SAN FRANCISCO-OAKLAND
BAY BRIDGE
SEISMIC SAFETY PROJECT

1. What caused the E2 anchor bolts manufactured in 2008 to fail?

Failure of 2008 Bolts Due to Hydrogen Embrittlement

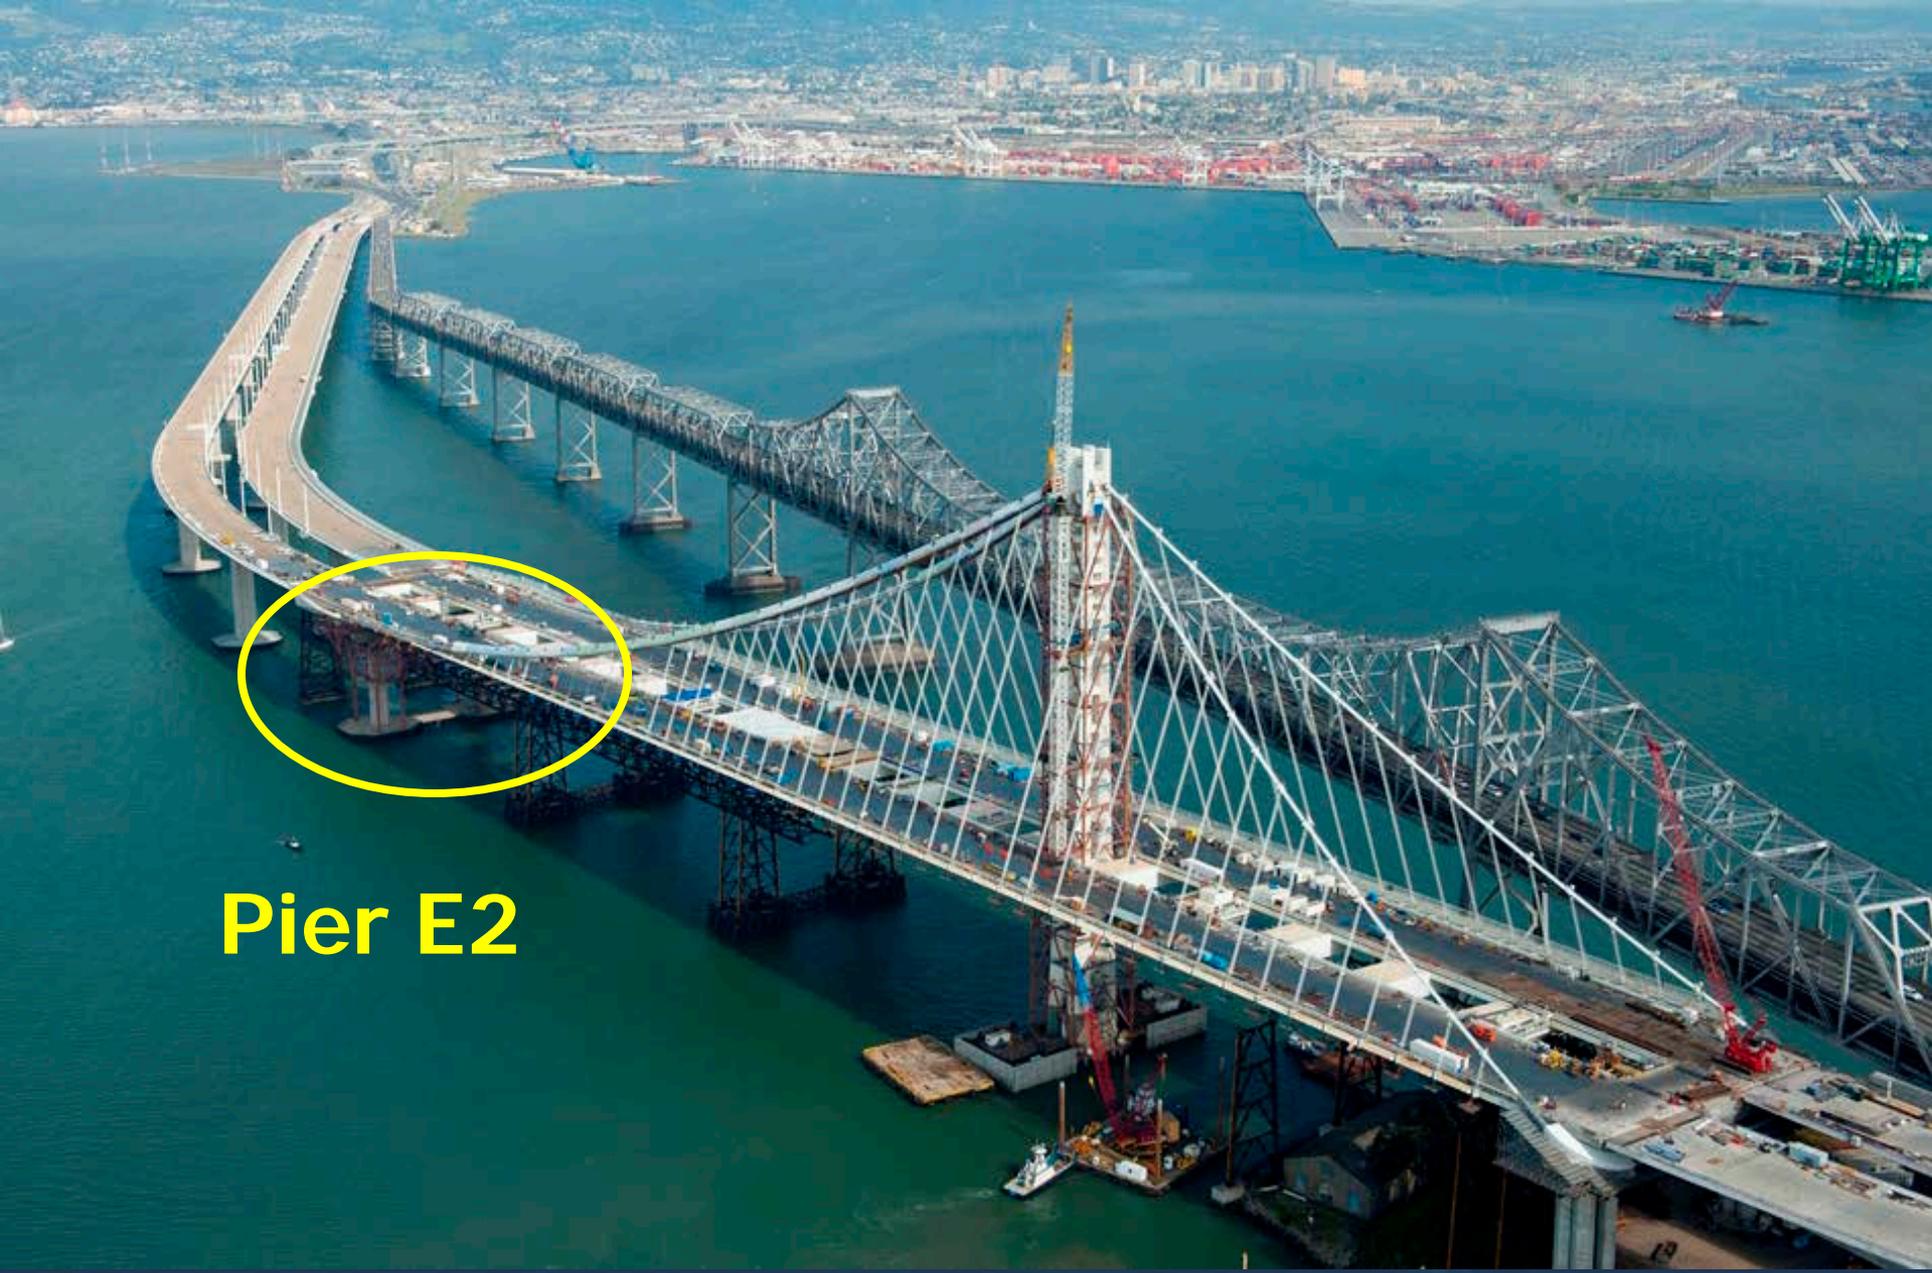
Pier E2

- Bearings and shear keys are secured to E2 by 3 inch diameter anchor bolts, ranging from 9 feet to 24 feet in length.
- 96 bolts manufactured in 2008 shown in red are embedded in the pier.
- 192 bolts manufactured in 2010 shown in blue are not embedded in pier.
