Briefing on E2 Anchor Bolts – May 8, 2013

THE SAN FRANCISCO-OAKLAND
BAY BRIDGE
SEISMIC SAFETY PROJECT

1. What caused the E2 anchor bolts manufactured in 2008 to fail?

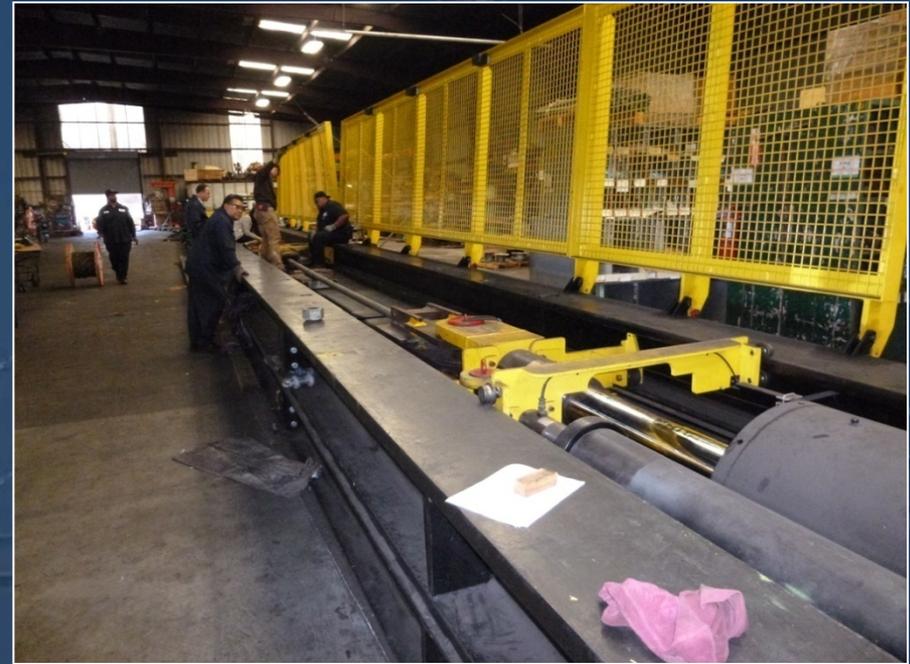
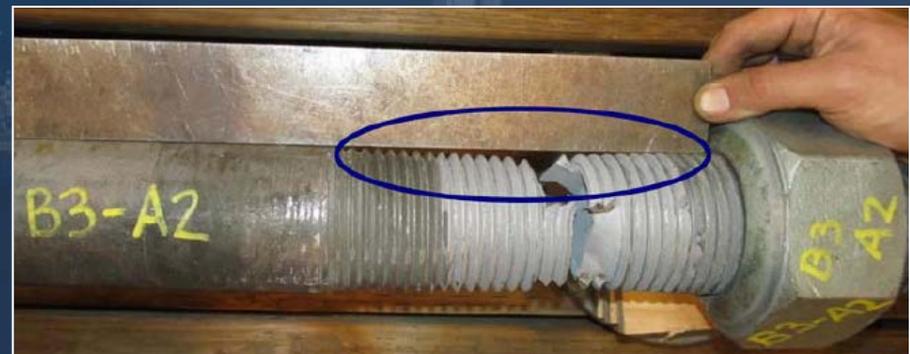
Preliminary 2010 Bolt Results

- No bolts have broken after more than a month of tensioning.
- Preliminary test results for 2010 bolts, including full sized destructive testing, show more ductile material properties and no hydrogen embrittlement.
- Additional testing results are anticipated, including surface hardness, toughness, microscopic examination, and corrosion testing

| | Tensile (KSI) | Yield (KSI) | Elongation (%) | Reduction of Area (ROA) | Hardness (HRC) | Charpy Toughness (ft-lb) |
| ASTM Requirements D > 2 ½" | 140 (min) | 115 (min) | 14 (min) | 40 (min) | 31-39 | N/A |
| 2008 E2 Bottom Average | 164 | 142 | 14 | 48 | 37 | @40° - 13.5 @70° - 16.2 |
| 2010 E2 Bottom Average | 159 | 139 | 16 | 51 | 34 | @40° - 37.2 @70° - 37.7 |

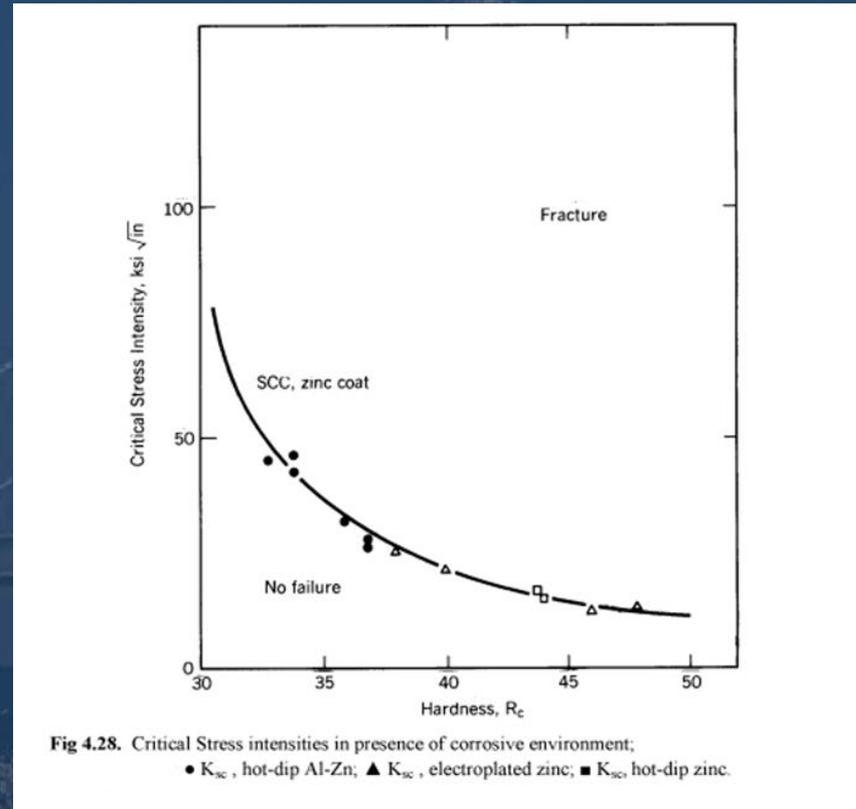
Fig 4.28. Critical Stress intensities in presence of corrosive environment;
● K_{SC} , hot-dip Al-Zn; ▲ K_{SC} , electroplated zinc; ■ K_{SC} , hot-dip zinc.

- Long term stress corrosion susceptibility is a function of the size and hardness of material, and level of tensioning.
- With the “wet” testing data, staff will be able to evaluate all similar high-strength bolts used on the project and help determine if additional remedial action is needed.
