RE: 390 Main Street Status Report – March 2012

**Project:** Renovation of 390 Main Street

**Subject:** Seismic Performance Levels

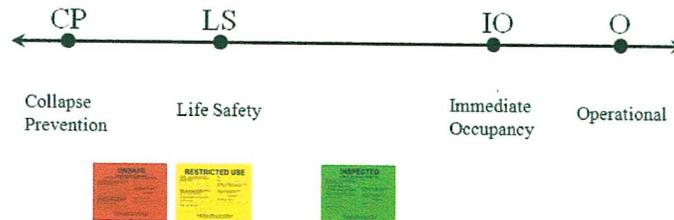
Building Performance Levels

The spectrum of commonly used seismic performance levels includes Collapse Prevention, Life Safety, Immediate Occupancy, and Operational, as shown on the graph below, with better performance towards the right.

The Life Safety Performance Level for the Design Basis Earthquake is the minimum required by code and therefore consideration of Performance Levels for this project should focus on the portion of the spectrum from Life Safety to Operational. There are distinctions between Immediate Occupancy and Operational, but both of them are essentially aimed at resuming occupancy of the building within a relatively short time frame. Life Safety is aimed at allowing the occupants to exit the building alive, but it does not protect the property itself from damage. A building that performs at the Life Safety Level may be damaged beyond the point of economical repair.
